STRUCTURE NUMBER: 056-3071

INSPECTION TYPE: 24 Month Routine

DATE: 05/06/2020

2020 HARTLAND TOWNSHIP BRIDGE INSPECTION PROGRAM

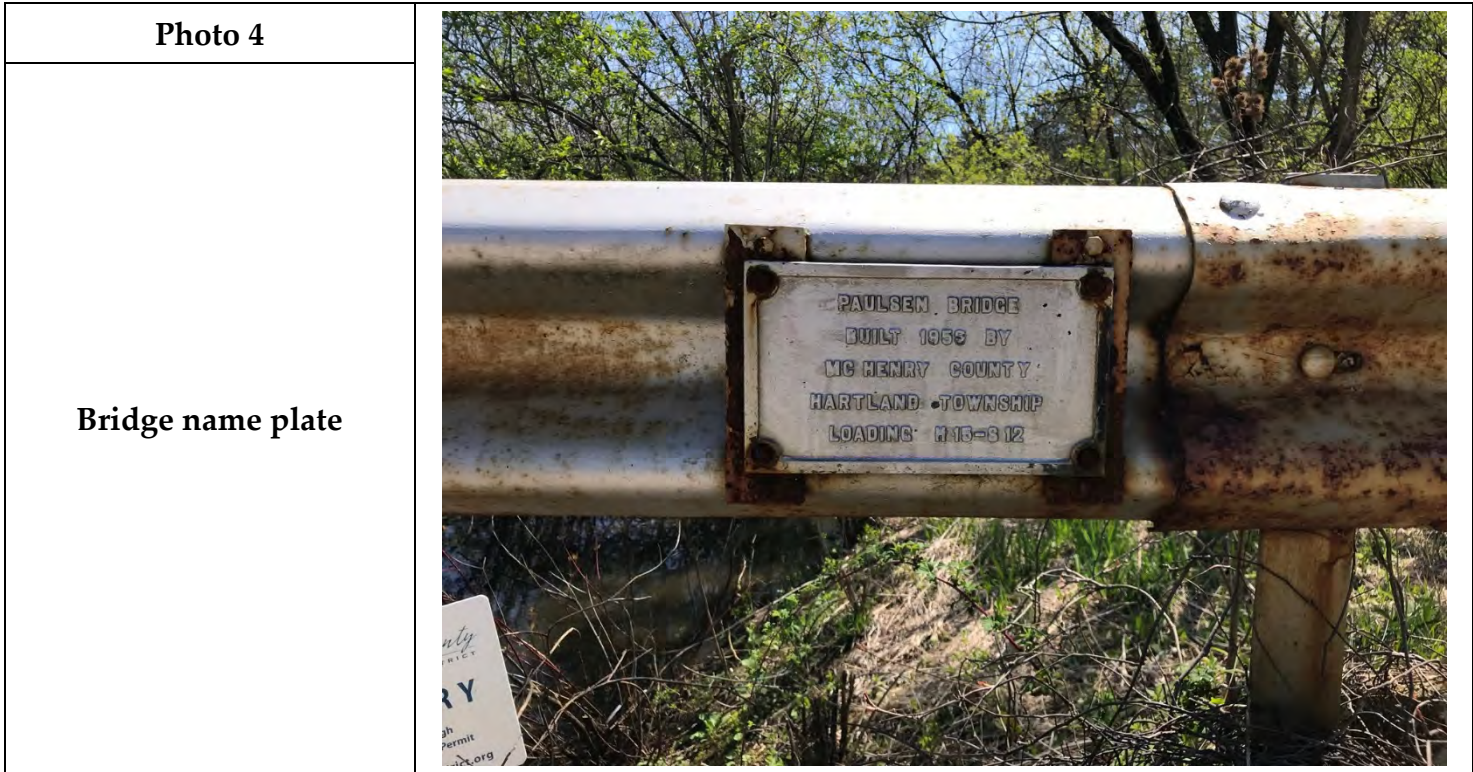
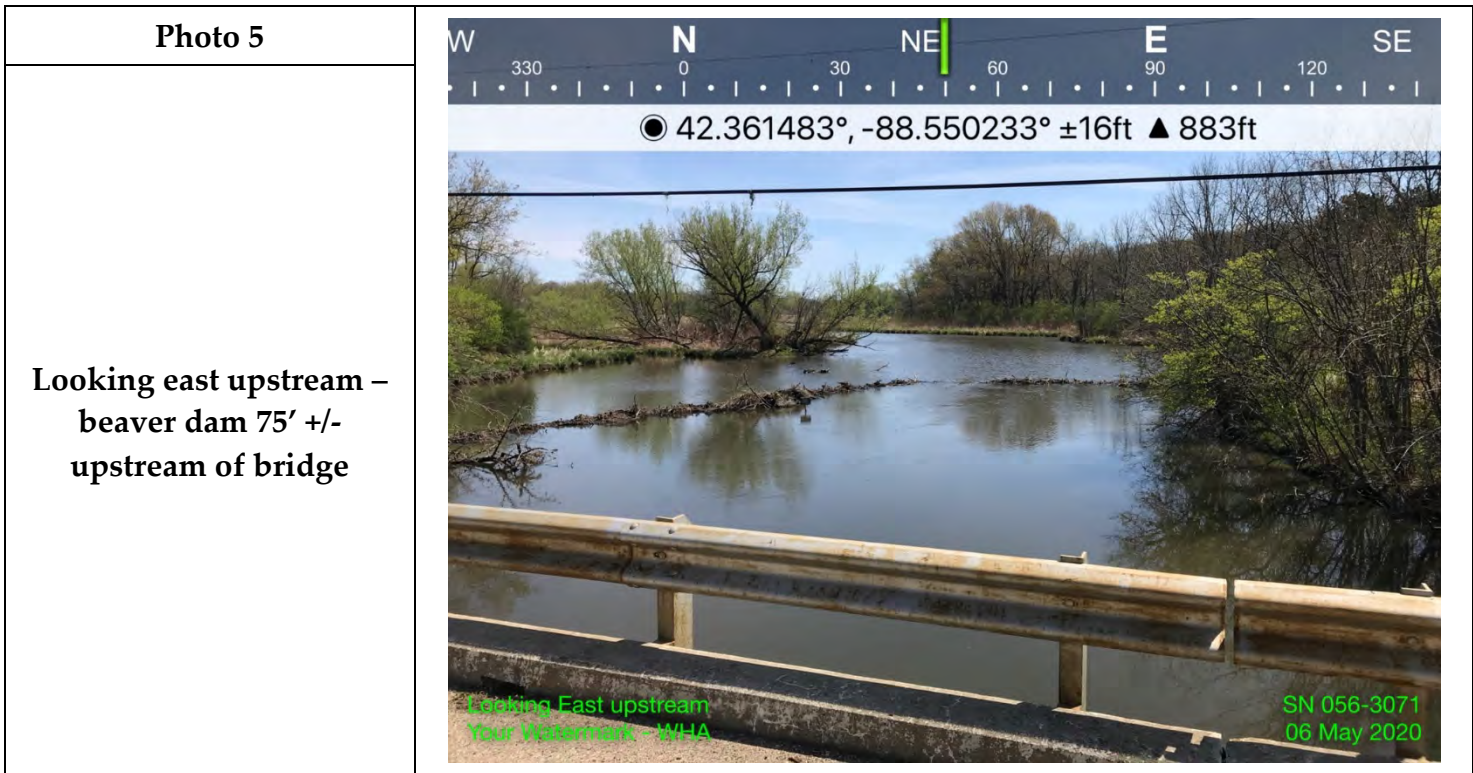
Looking East upstream
Your Watermark - WHA

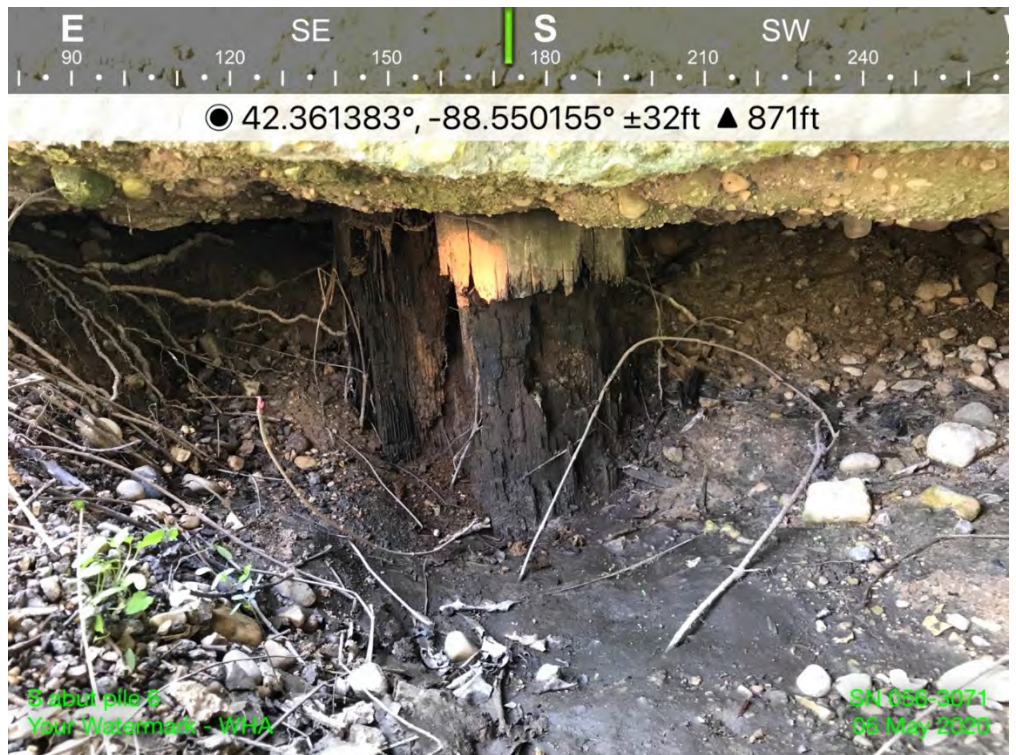
Photo 12

Pile #6 - soft, estimate 50% section loss

South abutment pile #6

Monitor timber pile deterioration 7 - 18

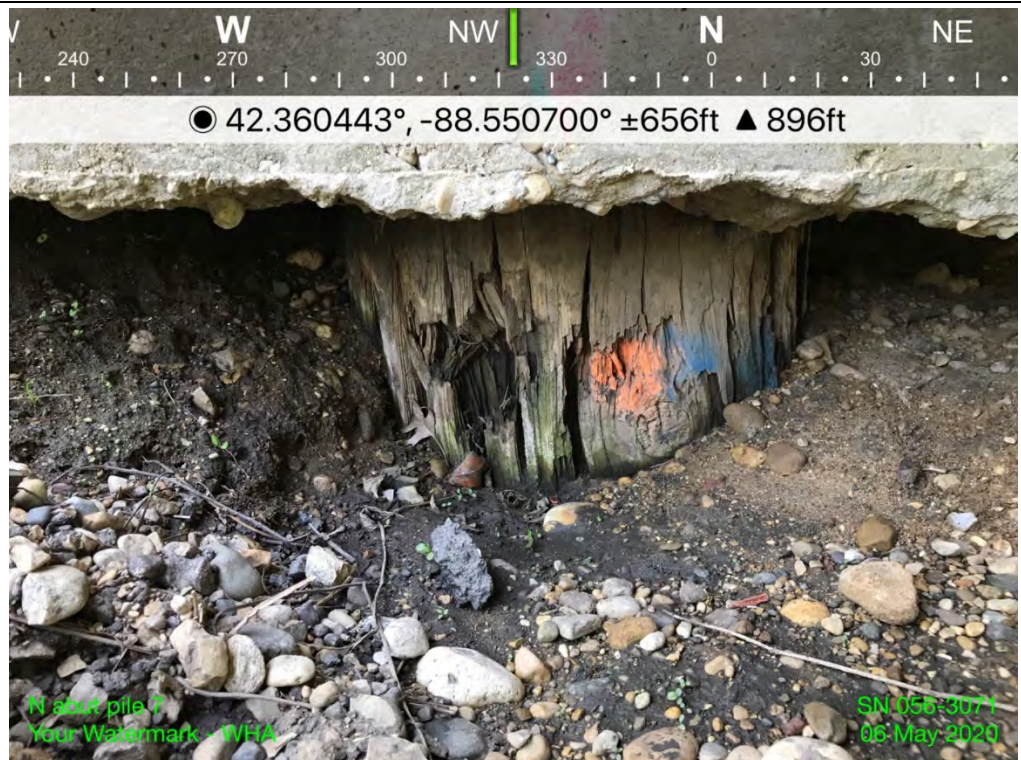
Photo 13

Pile #7 - soft

North abutment pile #7

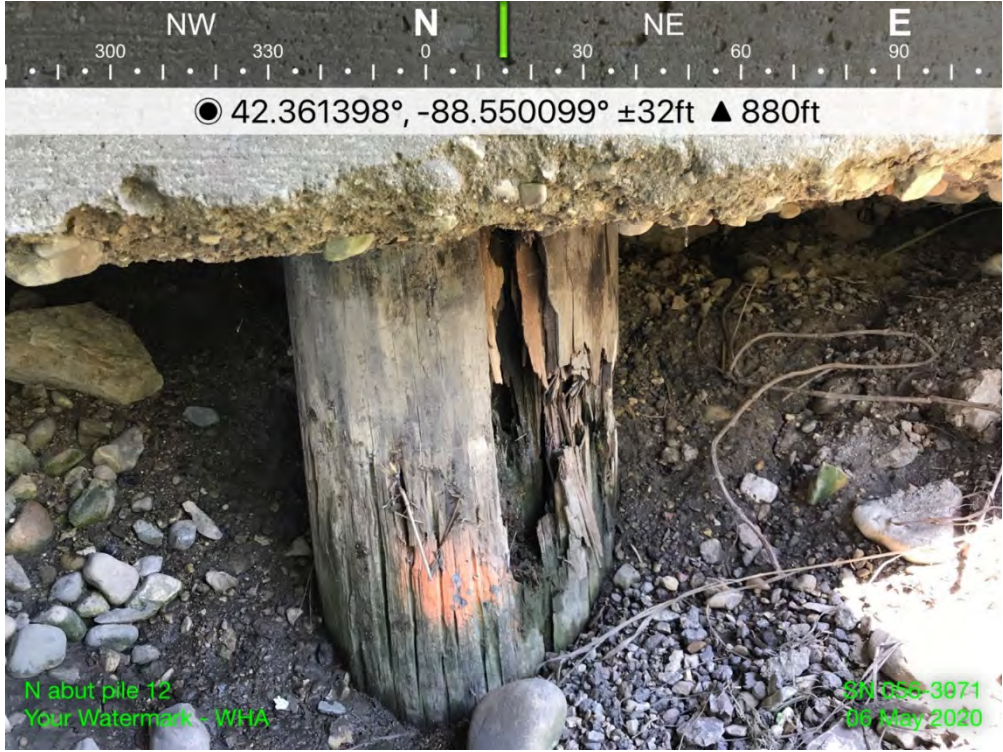
Photo 18

Pile #12 - soft, estimate 30% section loss

North abutment pile #12

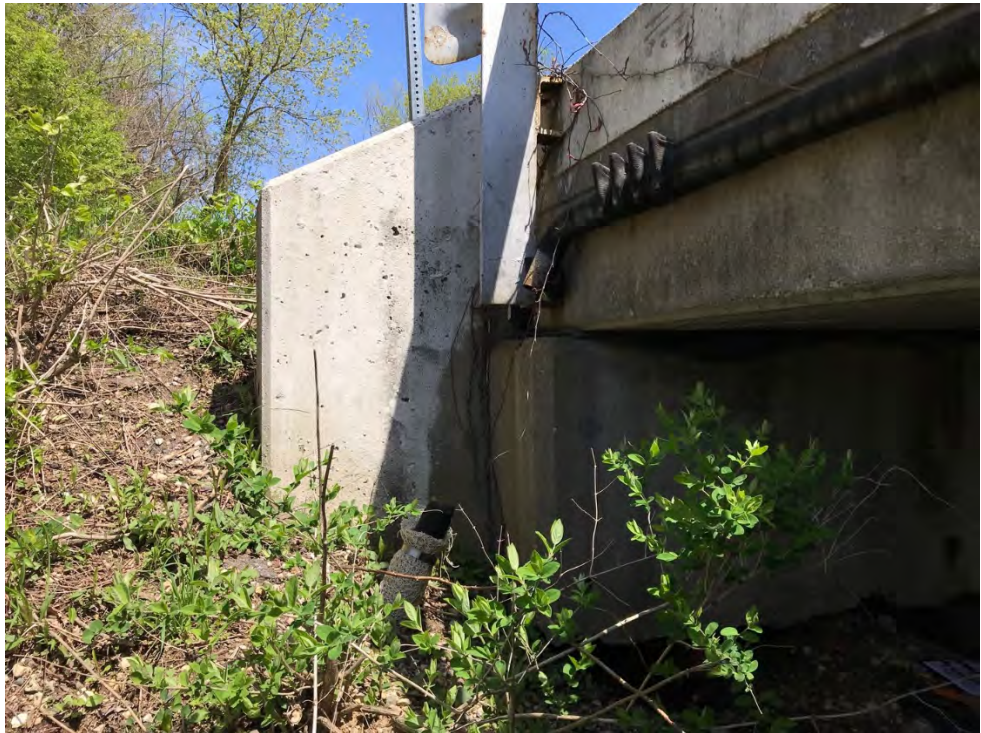
Photo 19

Natural gas line on west beam fascia disconnected

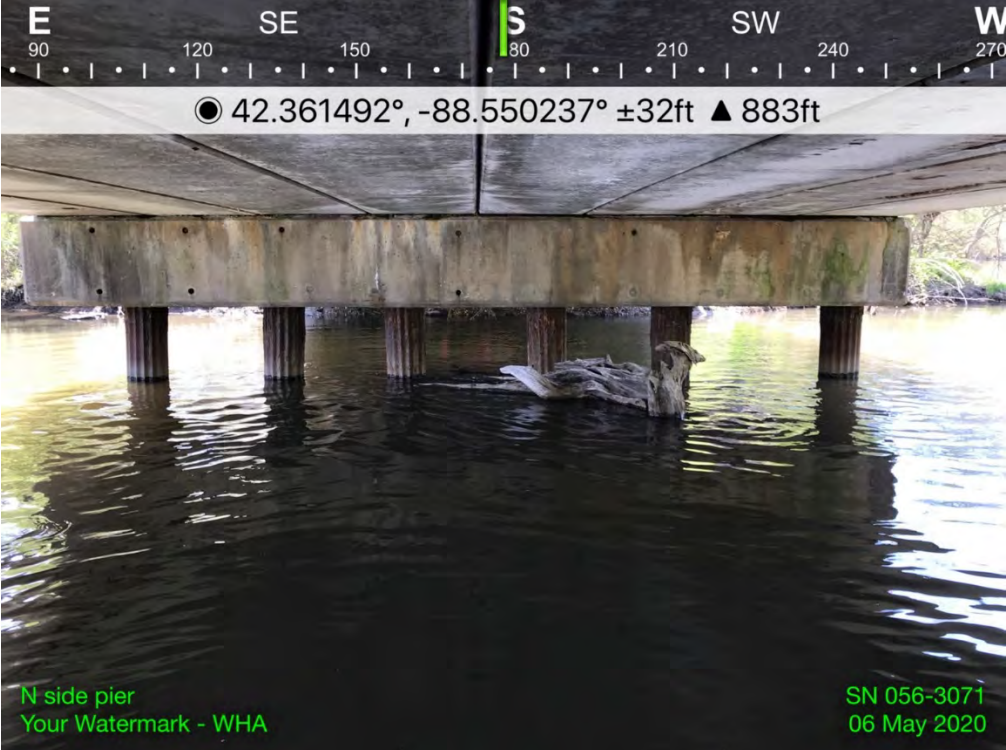
<p>Photo 20</p>

<p>A photograph taken from underneath a bridge, looking towards a concrete pier. The pier is supported by several vertical columns. A large piece of debris, possibly a log or branch, is caught on the north side of the pier. The water is dark and reflects the sky. The photo includes a compass overlay at the top with directions E, SE, S, SW, W and a scale from 90 to 270. Below the compass, the coordinates are given as 42.361492°, -88.550237° ±32ft ▲ 883ft. In the bottom left corner, there is a green watermark that reads 'N side pier' and 'Your Watermark - WHA'. In the bottom right corner, there is a green watermark that reads 'SN 056-3071' and '06 May 2020'.</p>
<p>Debris caught on north side of pier</p>

Remove debris from north side of pier 20

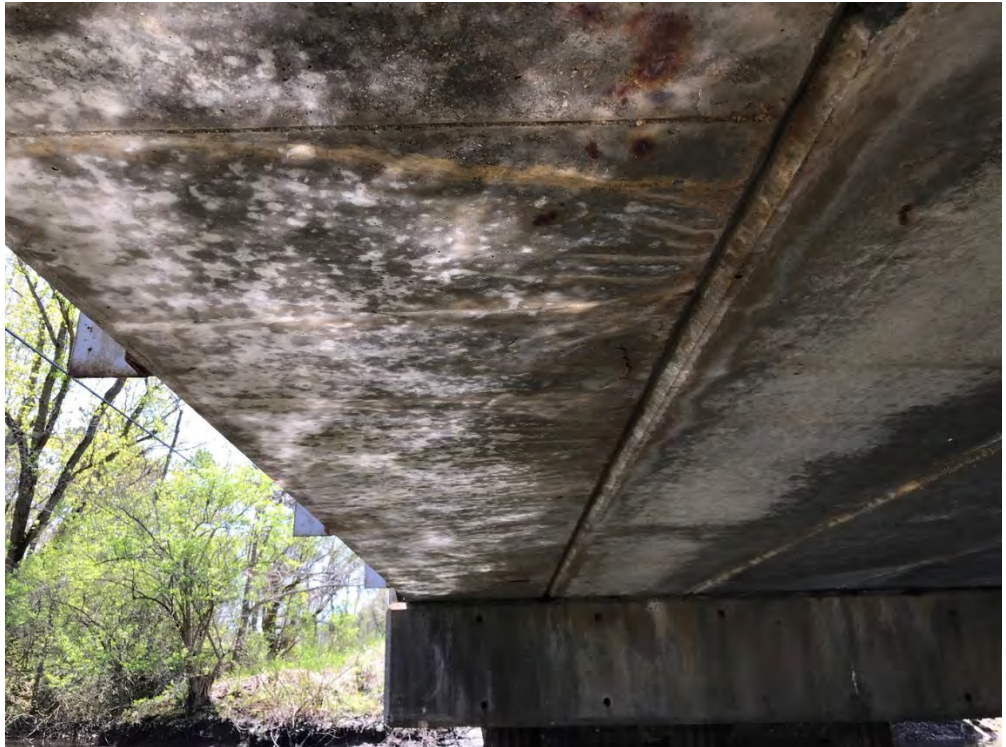
<p>Photo 21</p>

<p>A close-up photograph of the underside of a concrete beam. The surface shows signs of weathering and small delaminations, which are areas where the concrete has chipped away or separated. The background shows some green foliage and a clear sky.</p>
<p>North span east beam small delaminations</p>

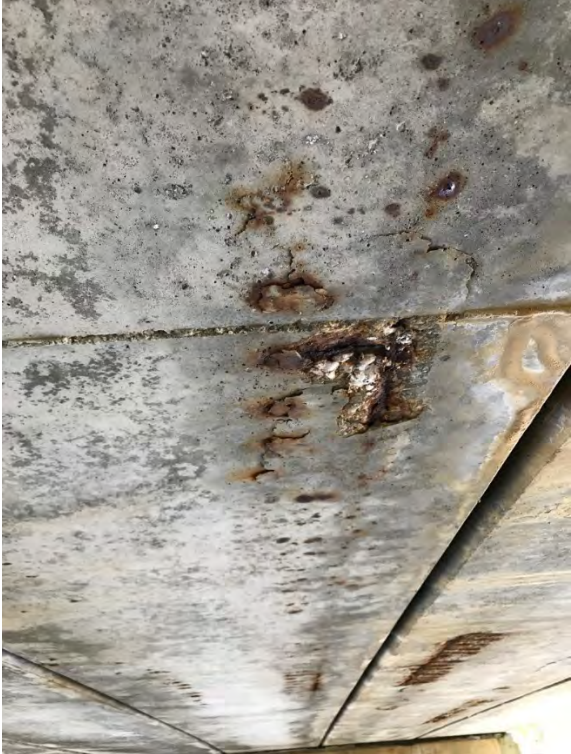
Photo 22

North span 3 rd beam from west spalls

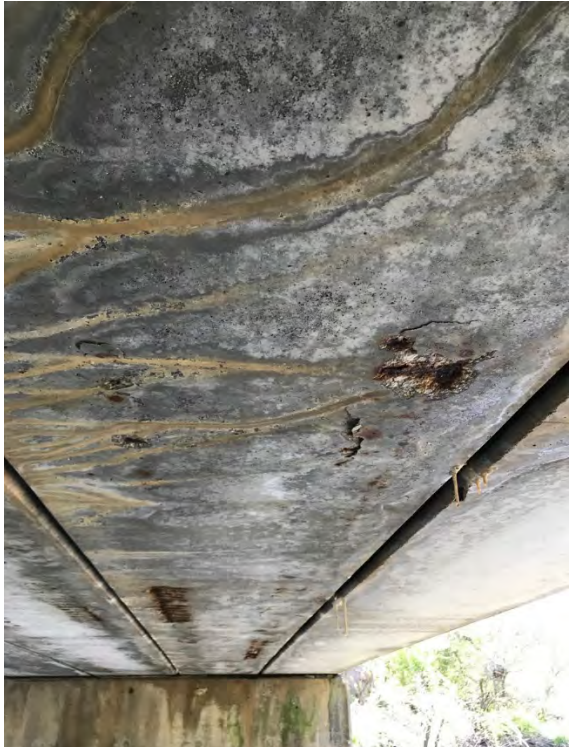
Photo 23

North span 2 nd beam from west spalls

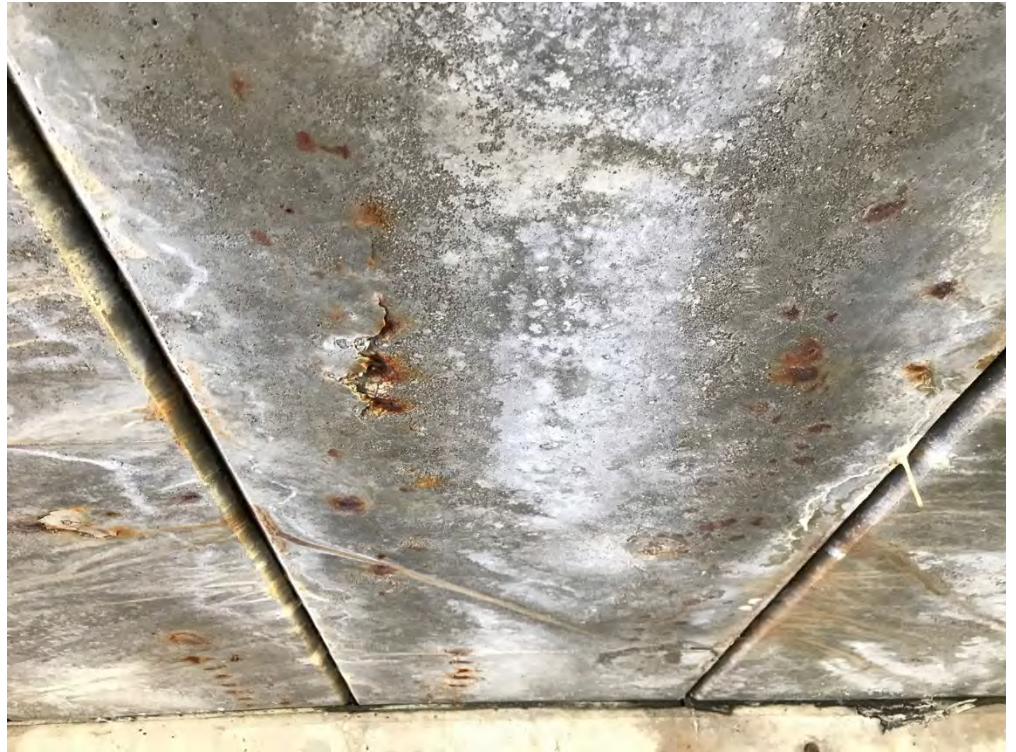
Photo 24

**South span 4th beam from
west spalls**

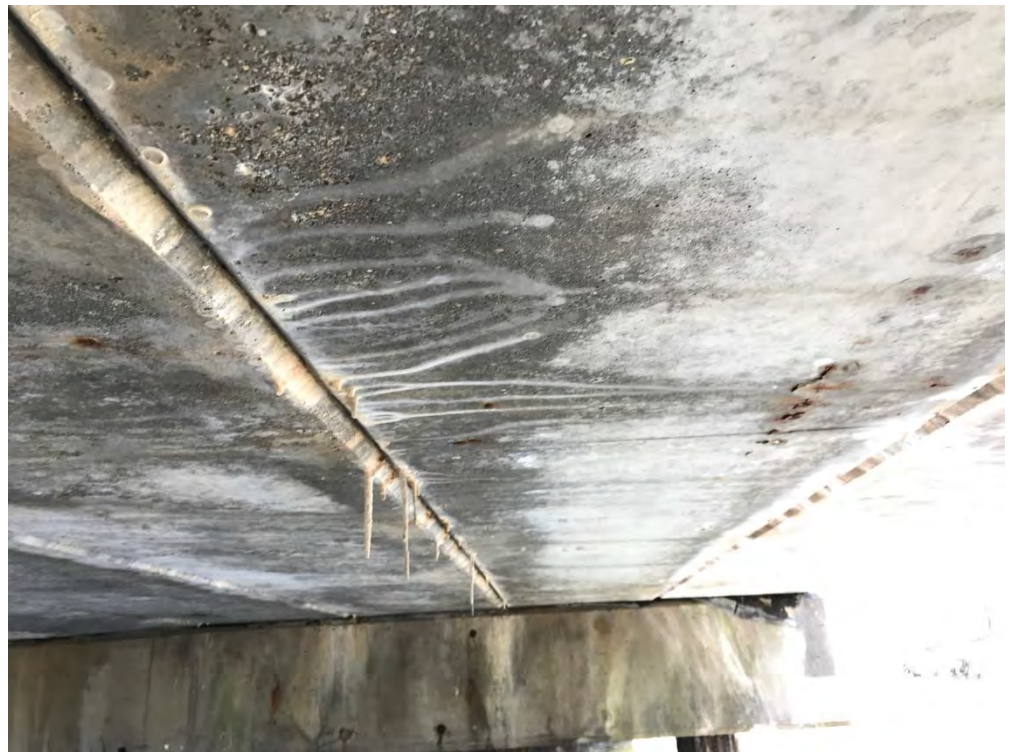
Photo 25

Leaking keyway joints
