STRUCTURE NUMBER: 056-3006

INSPECTION TYPE: Routine

2020 MCHENRY COUNTY COUNTY & TOWNSHIP BRIDGE INSPECTION PROGRAM

STRUCTURE NUMBER:	056-3006
ROAD NAME:	Charles Road
FEATURE CROSSED:	Slough Creek
TOWNSHIP:	Greenwood
COMMENTS:	<ul style="list-style-type: none"> - Longitudinal crack at 3rd beam in from south at east end of beam. - 2 spalls with exposed stirrup bars at mid span of north beam. - $\pm 8''$ of bit. overlay may exceed allowable design overlay thickness. - Severe collision damage to north beam in west approach span causing large areas of concrete section loss at 3 bridge post locations. - Large spall and heavy scaling with exposed rebar at north end of west abutment stem. - Map cracking with leaching at north and south abutment stems, all wingwalls with spalling and exposed rebar.

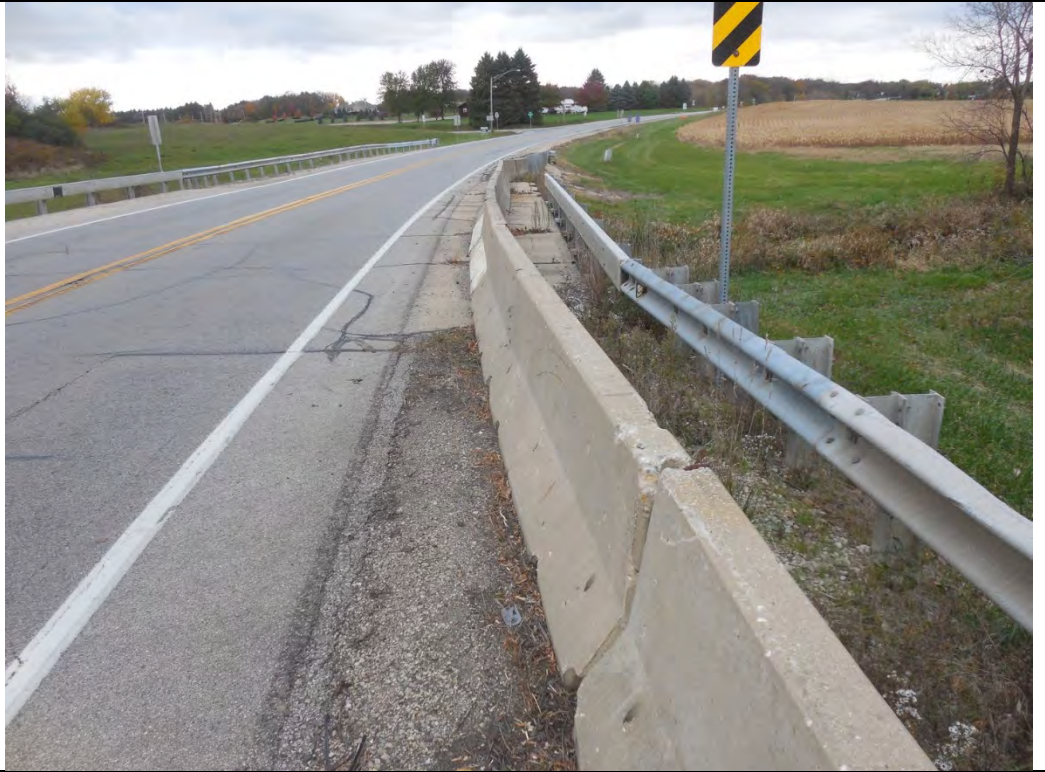
Photo 2

Viewing temporary
concrete barrier wall.

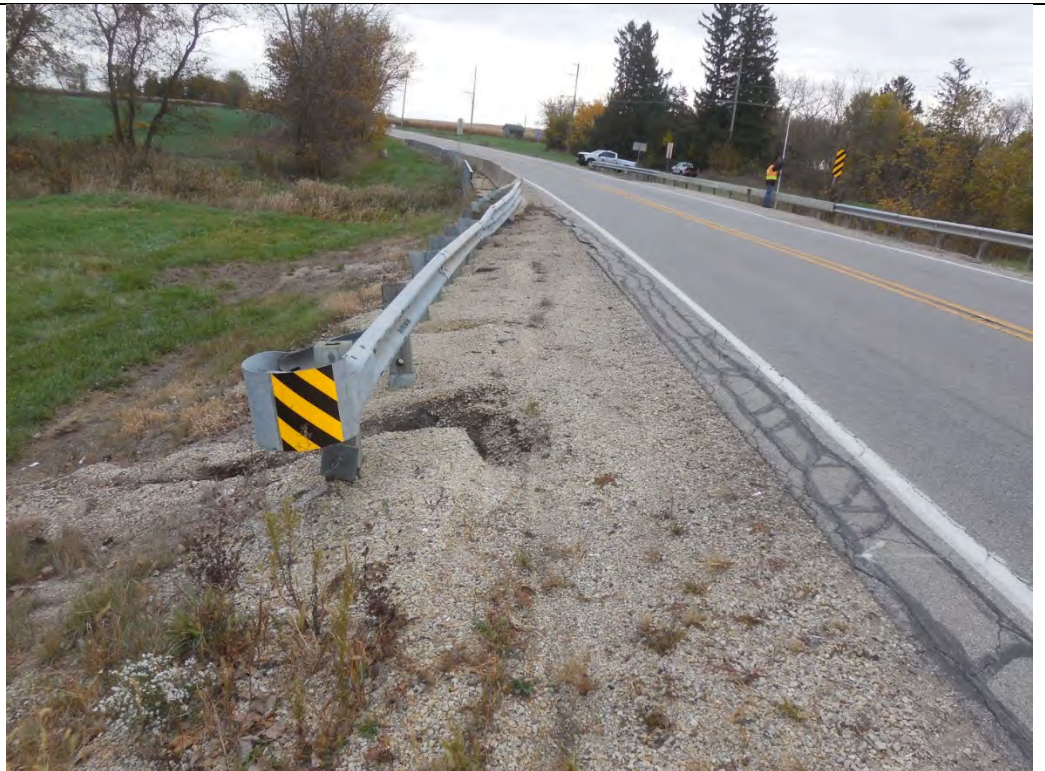
Photo 3

Viewing large washout in
aggregate shoulder.

REPAIR AGGREGATE SHOULDER..... 3 & 4

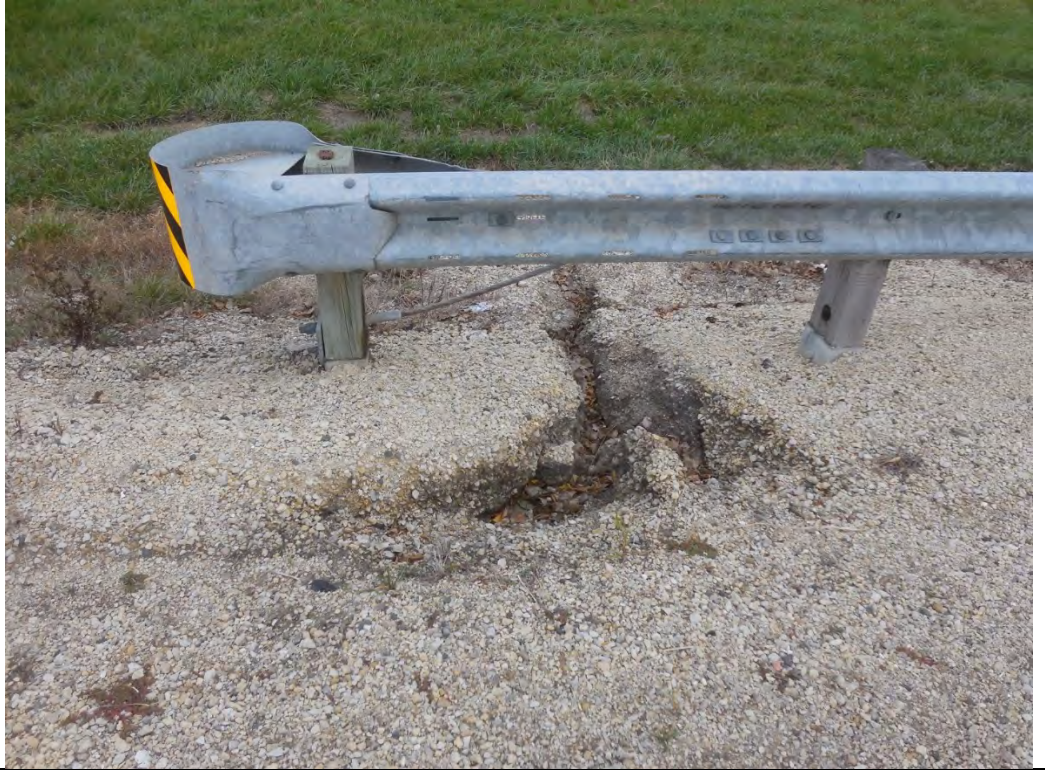
Photo 4

Viewing large washout in
aggregate shoulder.

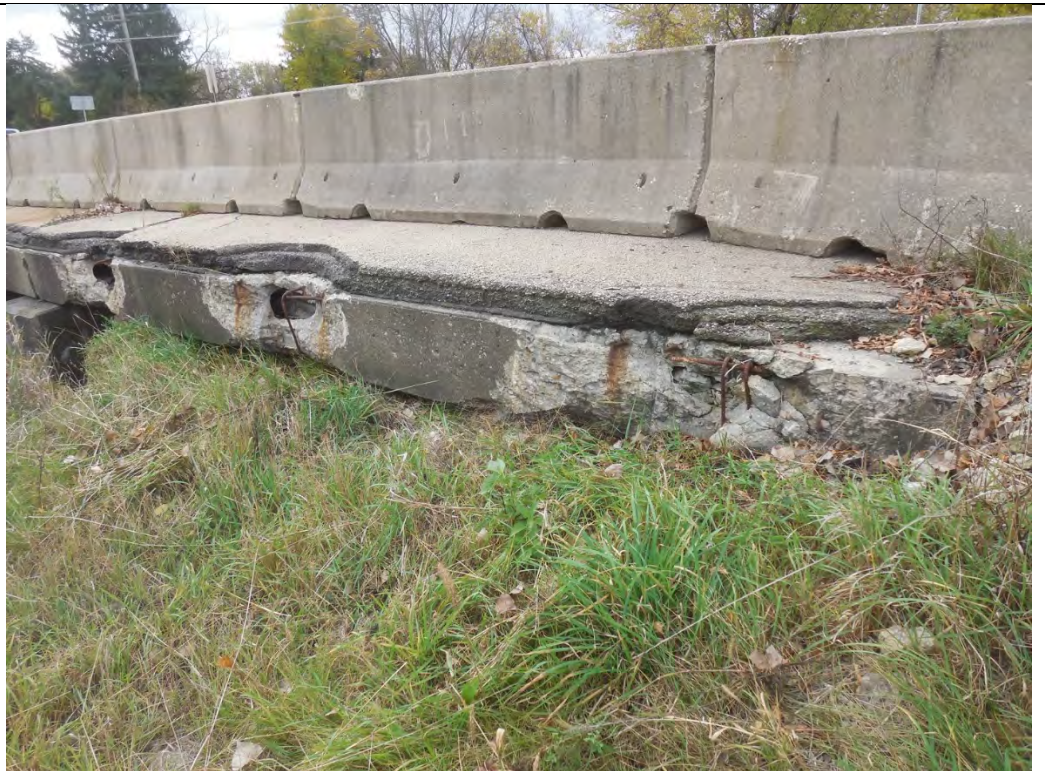
Photo 5

Viewing collision
damage to outer beams.
