STRUCTURE NUMBER: 056-3006

INSPECTION TYPE: Routine

2022 MCHENRY COUNTY COUNTY & TOWNSHIP BRIDGE INSPECTION PROGRAM

STRUCTURE NUMBER:	<i>056-3006</i>
ROAD NAME:	<i>Charles Road</i>
FEATURE CROSSED:	<i>Slough Creek</i>
TOWNSHIP:	<i>Greenwood</i>
COMMENTS:	<ul style="list-style-type: none">• <i>Collison damage to North beam</i>• <i>Spalls with exposed rebar on NW corner of West abutment</i>• <i>Leaking keyways</i>

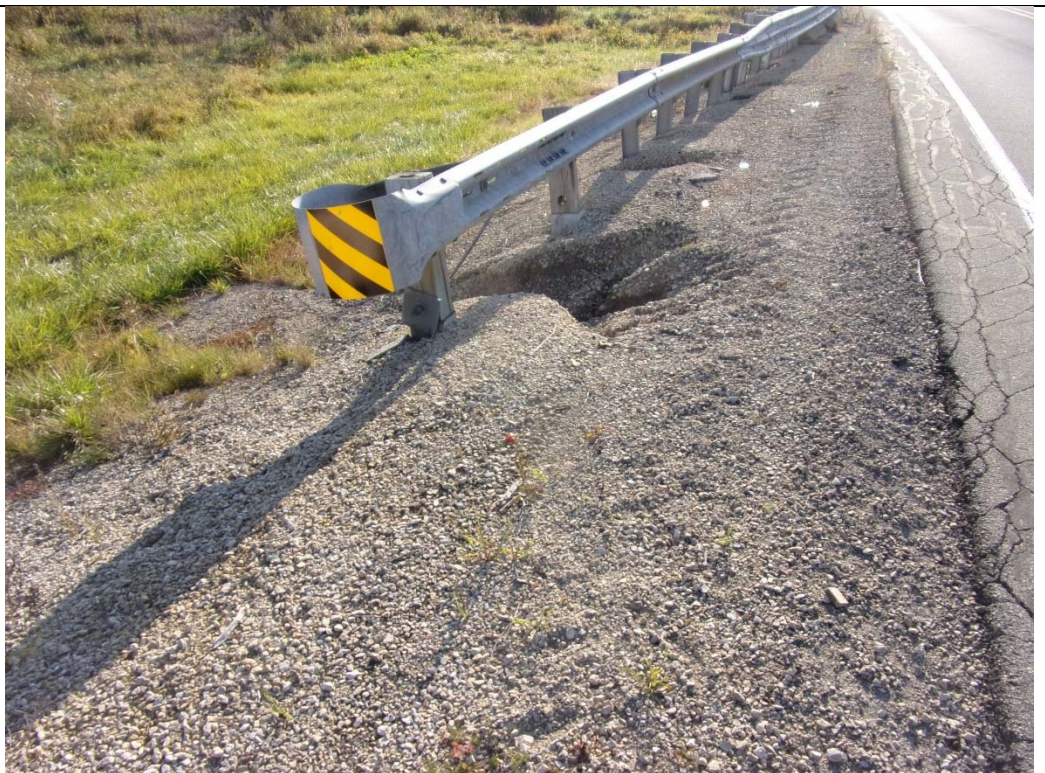
Photo 5
Scour in shoulder NW corn of guardrail

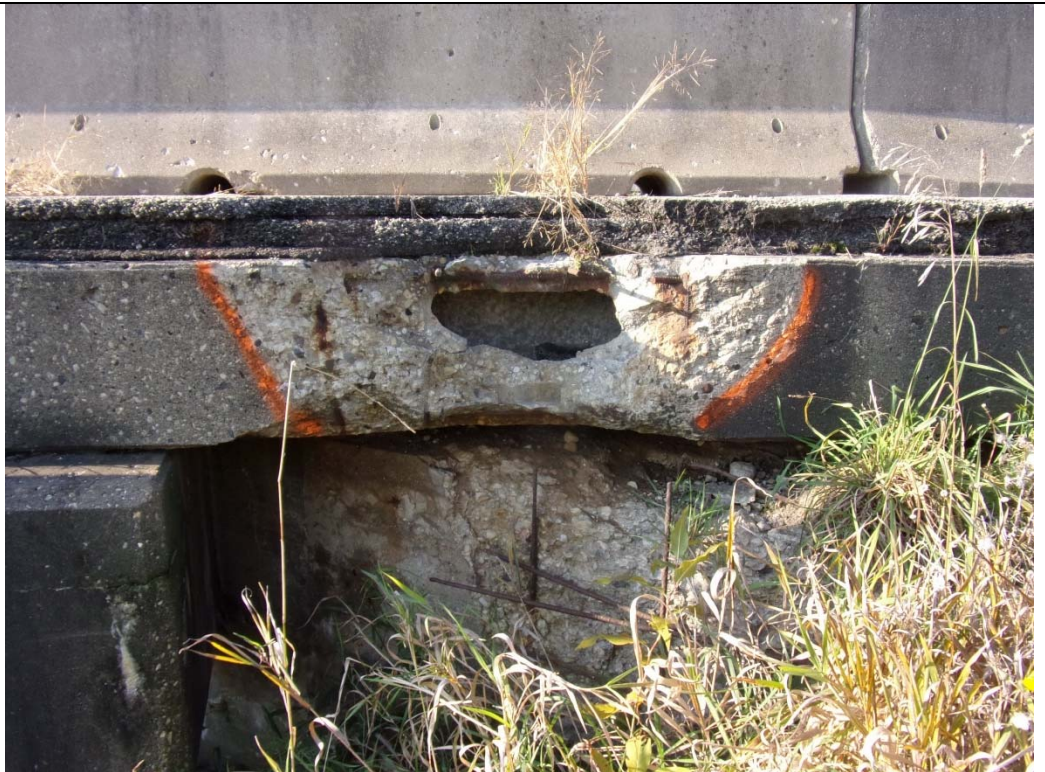
Photo 6
Viewing collision damage to outer beams.

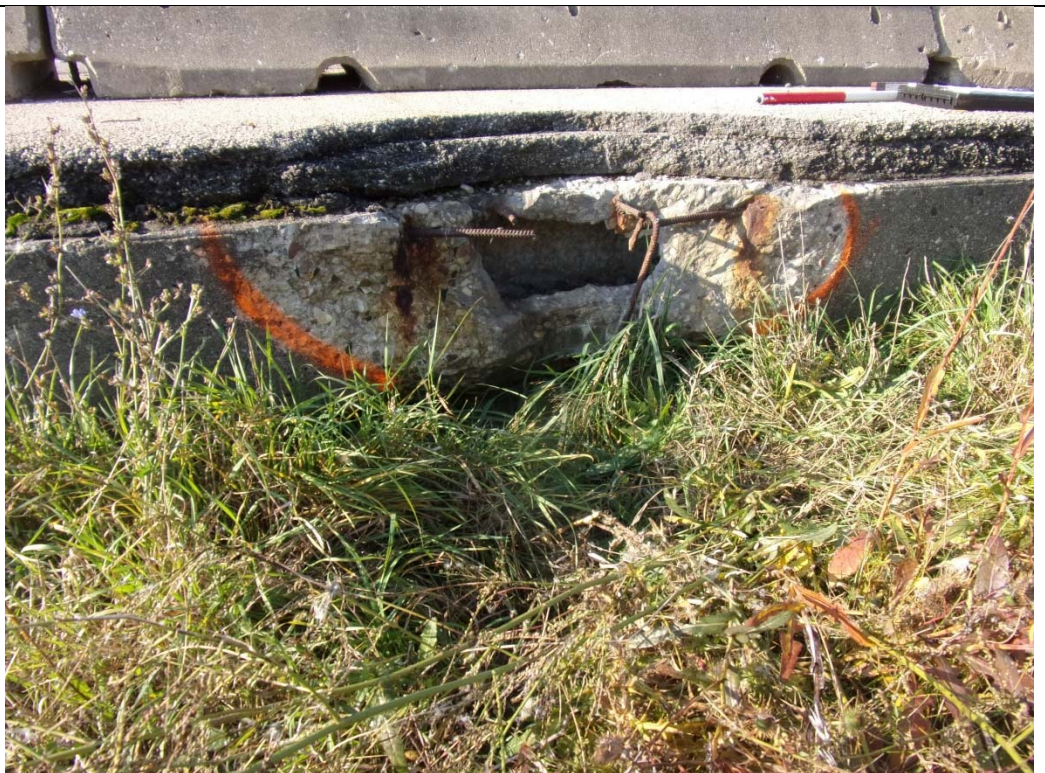
Photo 7
Viewing collision damage to outer beams.

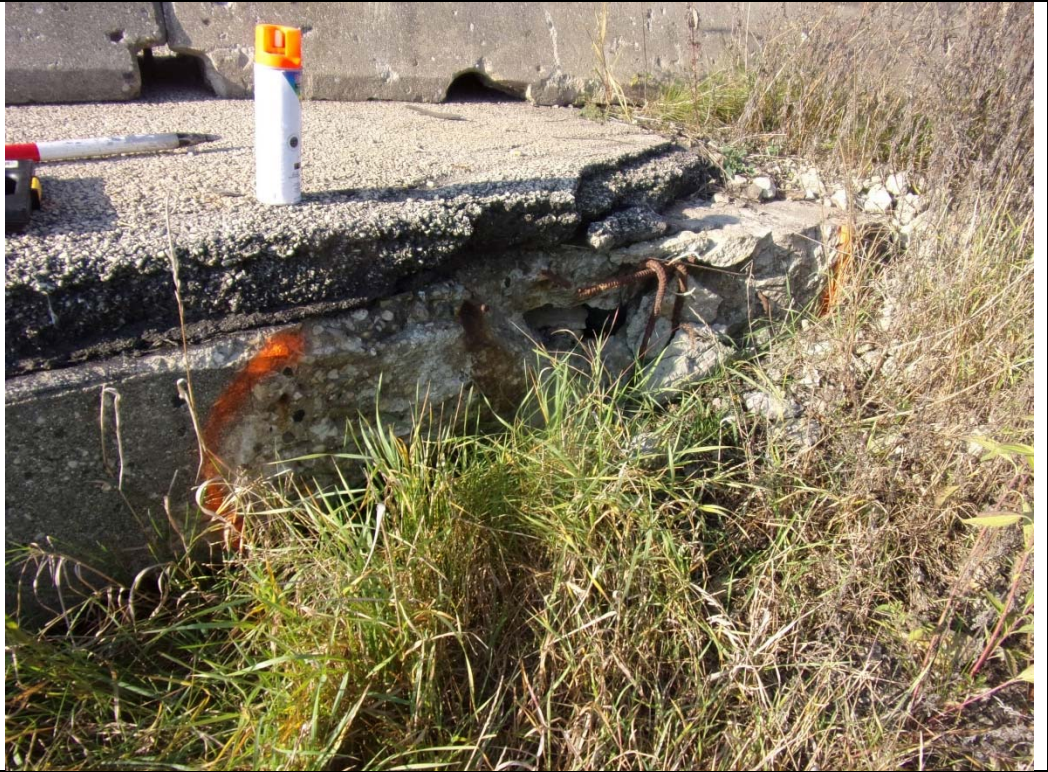
Photo 8

**Viewing collision
damage to outer beams.**

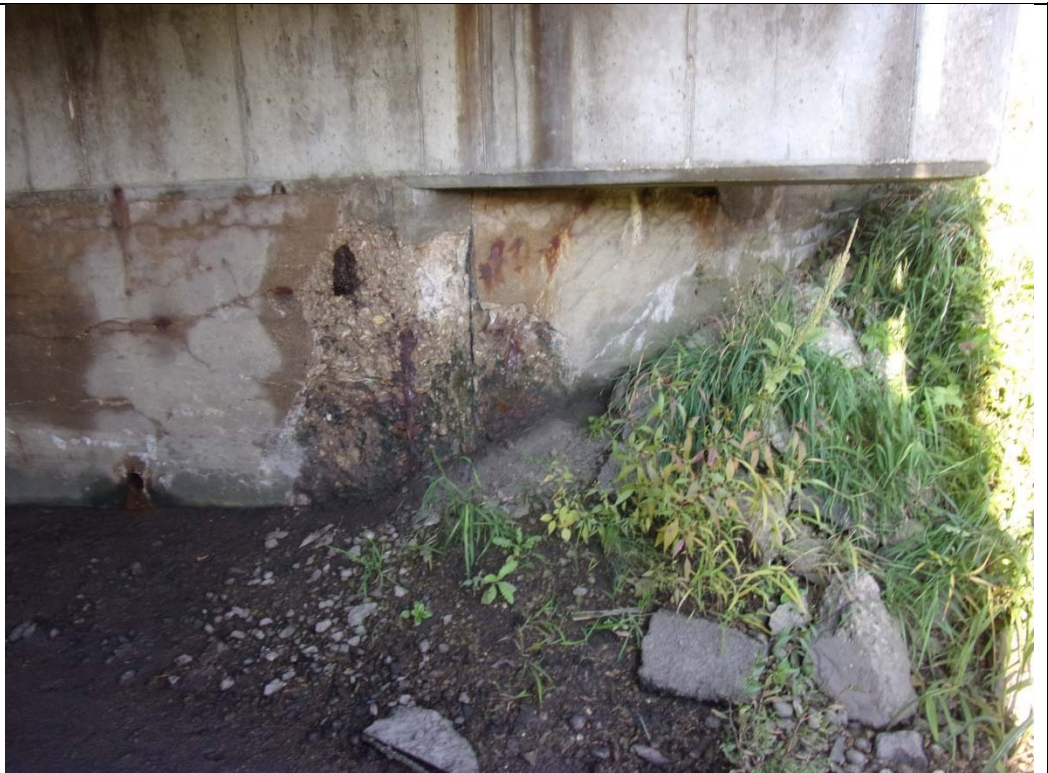
Photo 9

Item #58 & #59 - Longitudinal crack in beam in 3rd beam in from the South at East end of beam, exposed stirrups, leaking keyways
 Item #60 - Spalling and heavy scaling with exposed rebar at North end of West abutment

**Northwest corner
Of West abutment**
