BRIDGE INSPECTION

STRUCTURE NUMBER: 056-3071

INSPECTION TYPE: Routine & Special Feature

2022 MCHENRY COUNTY HARTLAND TOWNSHIP BRIDGE INSPECTION PROGRAM

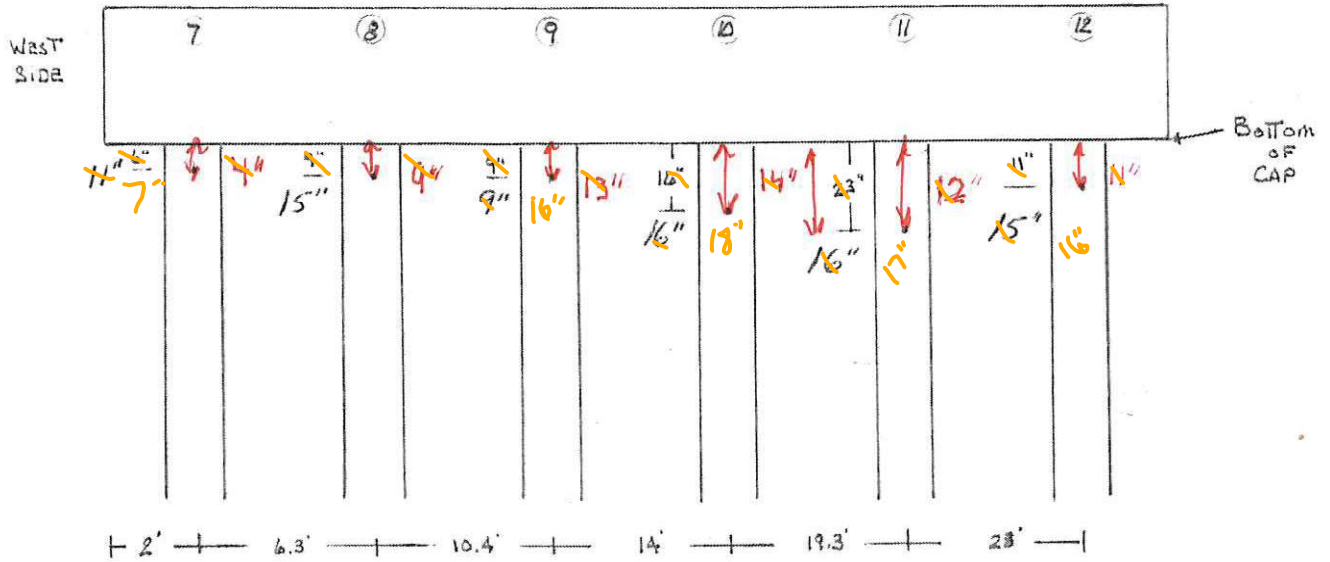
N. ABUT.

Amount of pile exposed.

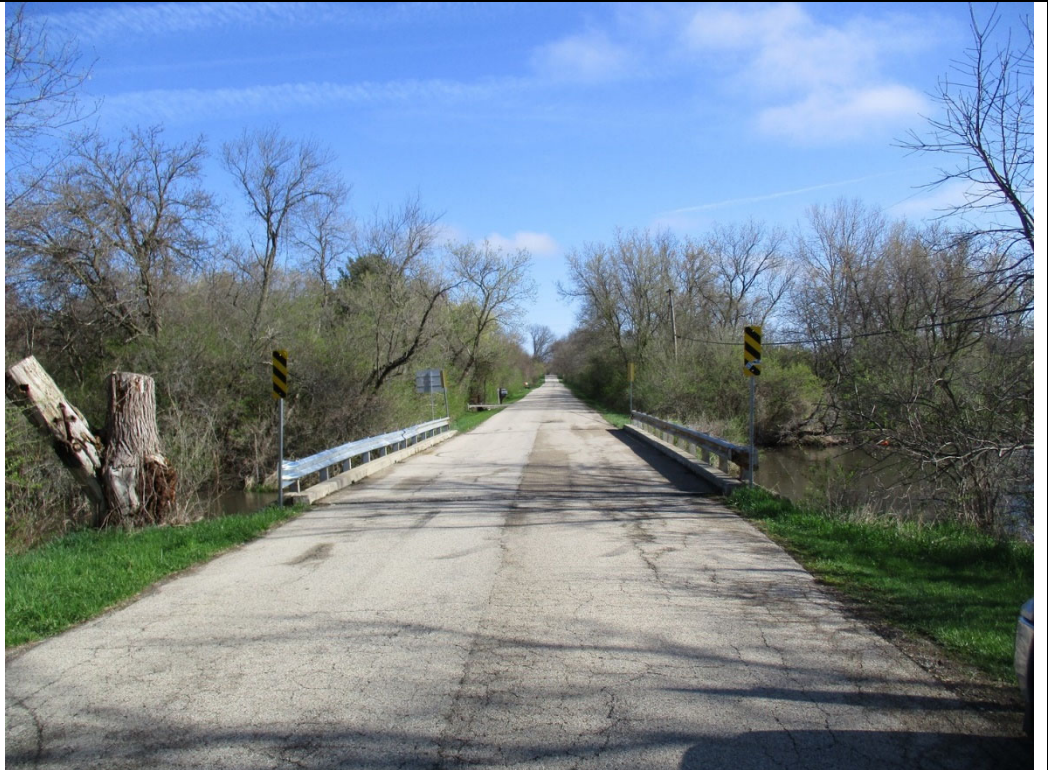
Photo 2	
Looking North, SE delineator facing wrong direction

Flip delineator in the SE corner so it points inward to center of roadway..... 2

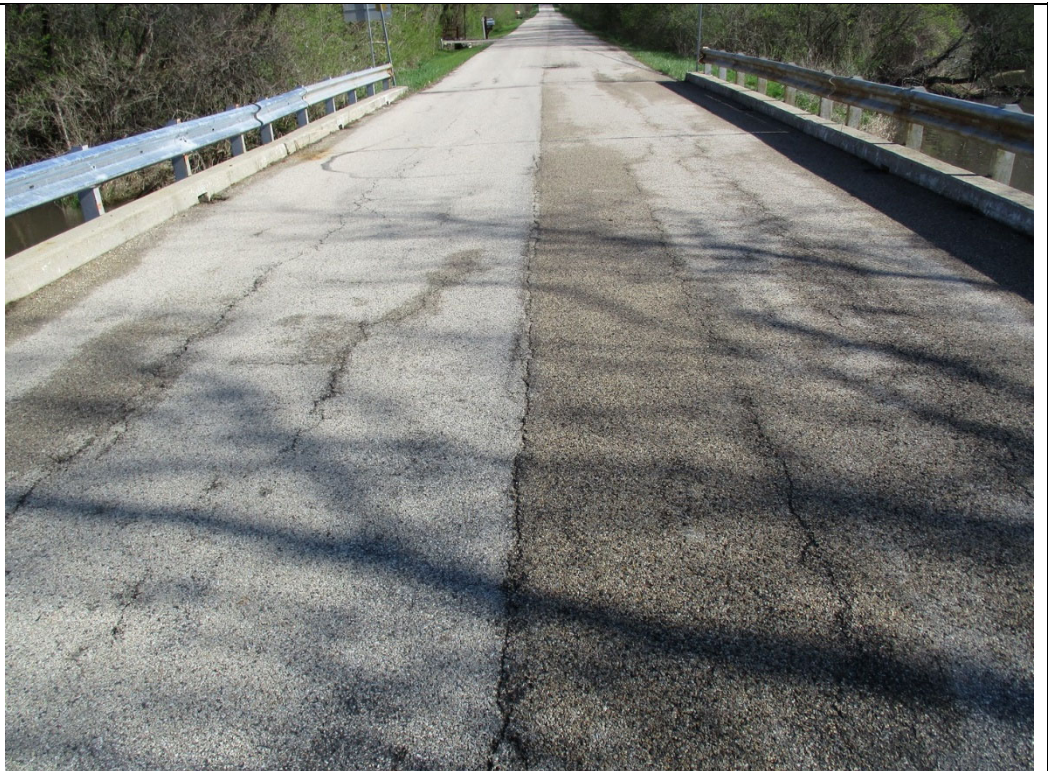
Items 58 & 59 - Significant keyway leakage. Minor spalls in several beams due to inadequate concrete cover. Longitudinal cracking in the HMA overlay showing signs the beams are acting independently. 2 longitudinal cracks in beam #4 in from the West in the South span. The North, span the 1st beam in from the East has 3 spalls in the beam exposing the longitudinal bars and wire mesh.

Photo 3	
Longitudinal cracking in the HMA overlay

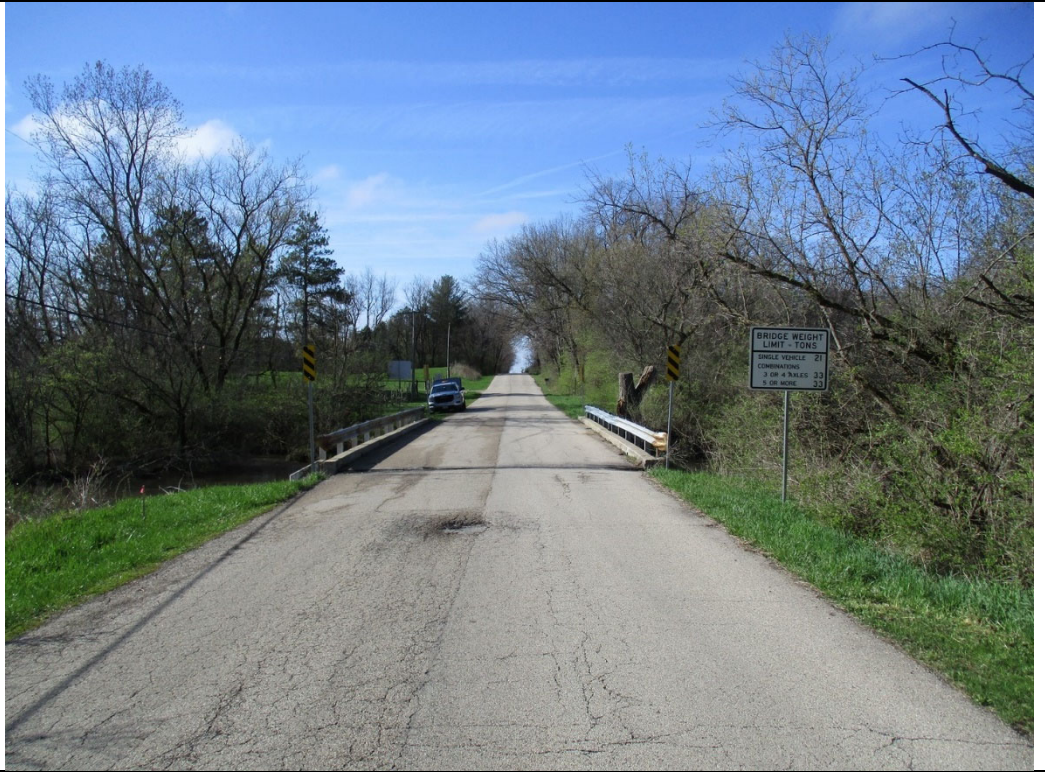
Photo 6

Looking south

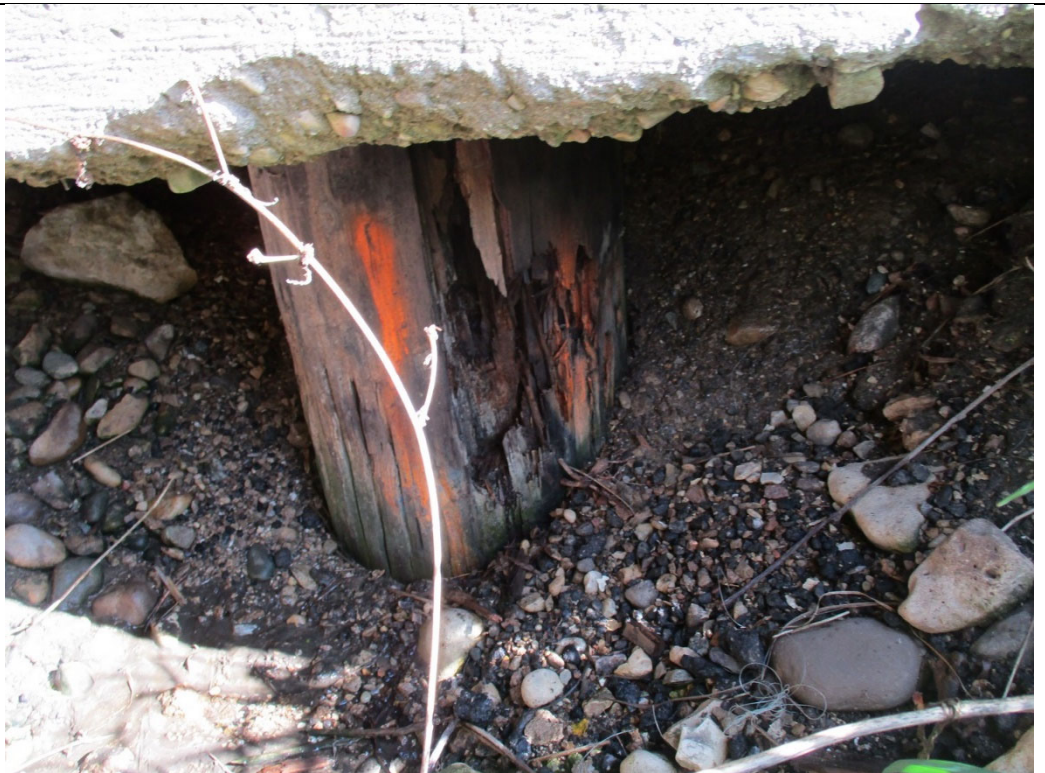
- Pile #7 - soft
- Pile #8 - soft
- Pile #9 - soft, estimate 20% section loss
- Pile #10 - soft
- Pile #11 - ok
- Pile #12 - soft, estimate 30% section loss

Pile #12

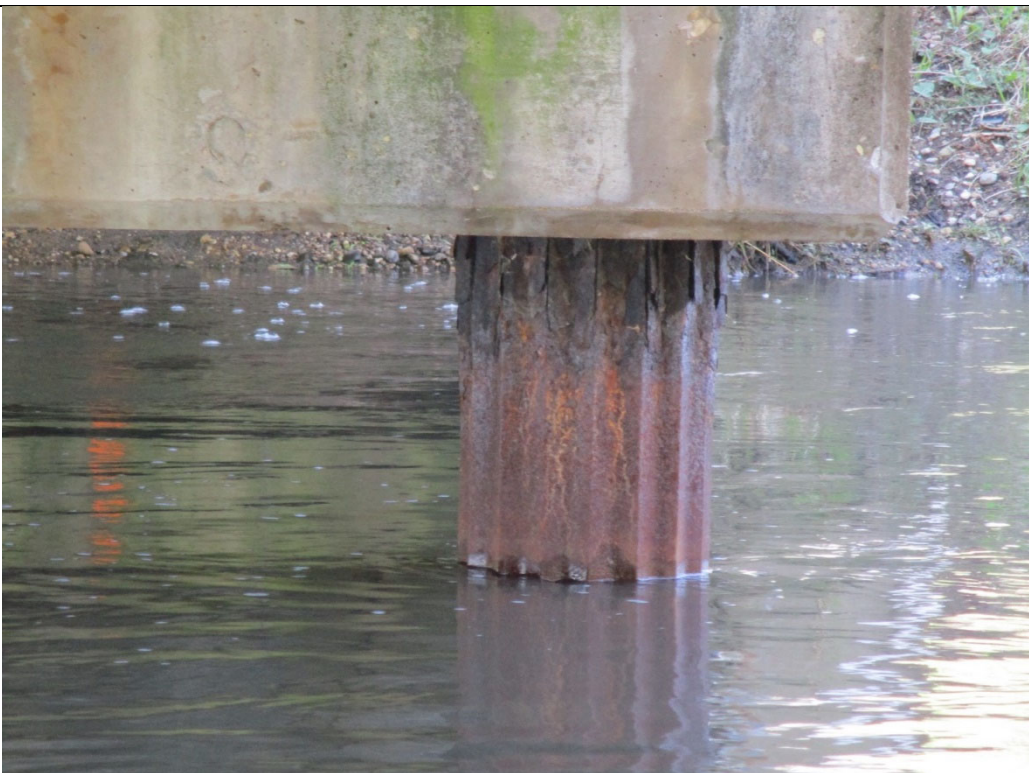
Photo 15

Heavy rusting on the steel pile encasements

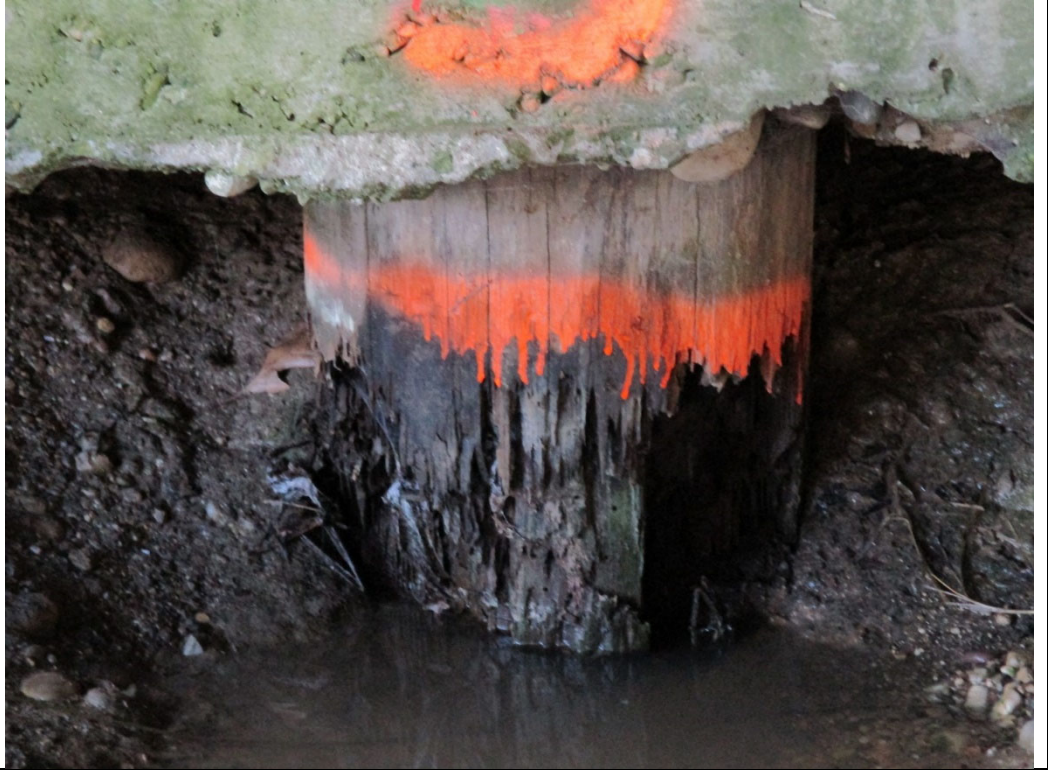
Photo 18

Pile #4 below has some extra minor section loss, see below.

- Pile #1 - soft, estimate 10% section loss
- Pile #2 - soft, estimate 25% section loss
- Pile #3 - soft, estimate 10% section loss
- Pile #4 - soft, estimate 5% section loss
- Pile #5 - soft, estimate 40% section loss
- Pile #6 - soft, estimate 50% section loss

Pile #4

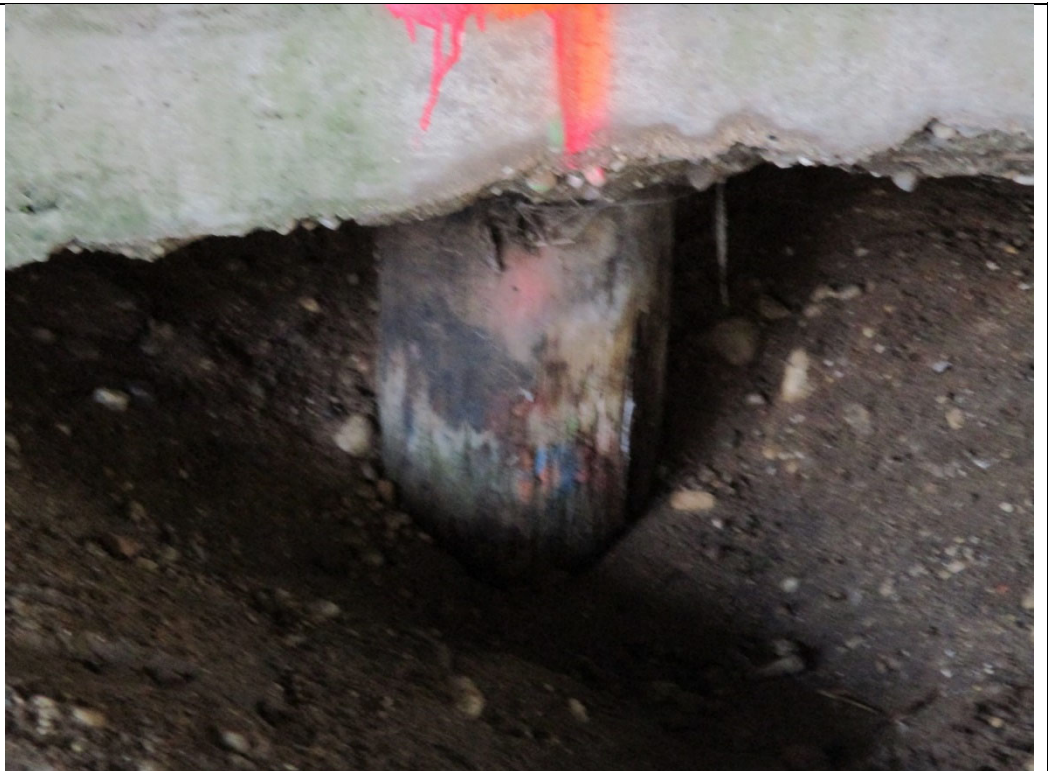
Photo 19

Pile #3
