McHenry County

Rural Survey

Algonquin Township

FIELD DATA SHEETS

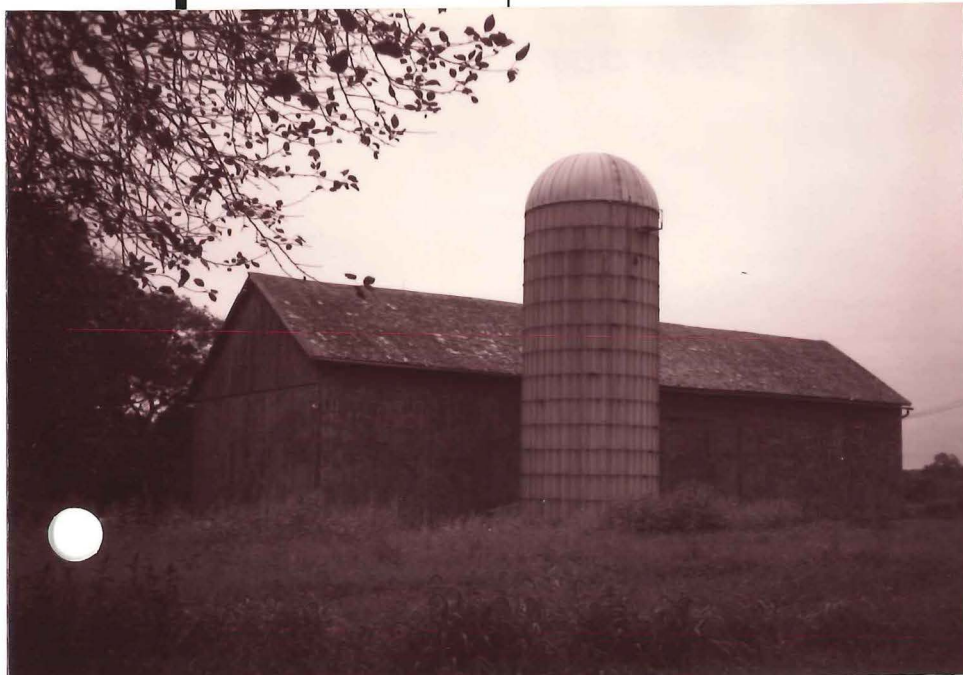
Circa: 1890	Condition: Poor	Integrity: Poor
-----------------------	---------------------------	---------------------------

Materials:	HISTORY:
Foundation: Concrete Walls: Vertical plank Roof: Wood shingles Porch:	Ramped transverse aisle, there is an extension in the middle of the barn of about 4 feet

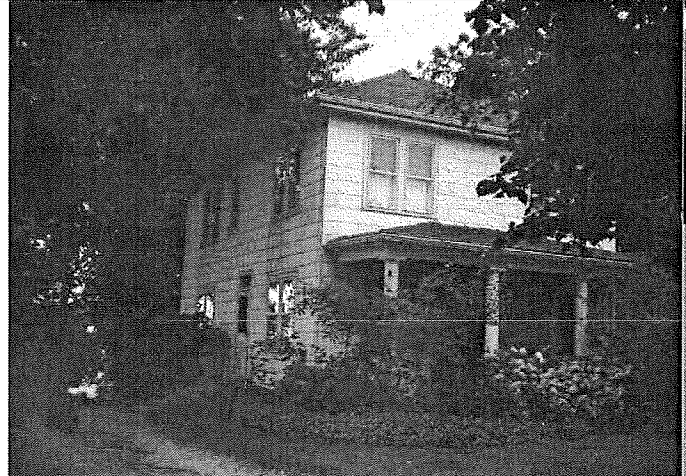
Roll No./Neg.No.: MM/30

Circa: 1930	Condition: Good	Integrity: Poor
-----------------------	---------------------------	---------------------------

Materials:	HISTORY:
Foundation: Poured	Hipped roof
Walls: Asbestos	Original columns intact
Roof: Asphalt shingles	Original 3 over one windows intact
Porch: Front w/ pillars	Suitable for restoration if asbestos siding is removed
	Previous site = 1995

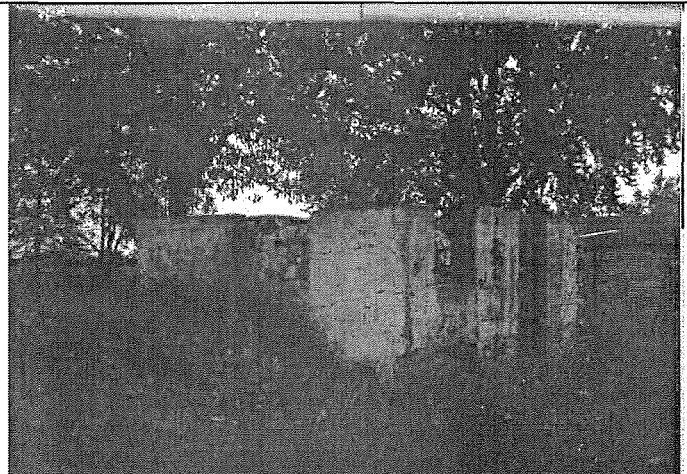
Roll No./Neg.No.: NN/7

Circa: 1920	Condition: Poor	Integrity: Poor
-----------------------	---------------------------	---------------------------

Materials:	HISTORY:
Foundation: Concrete and stone	Missing doors and windows and roof
Walls: Stone covered with concrete	Possible former milk house
Roof: Missing	
Porch:

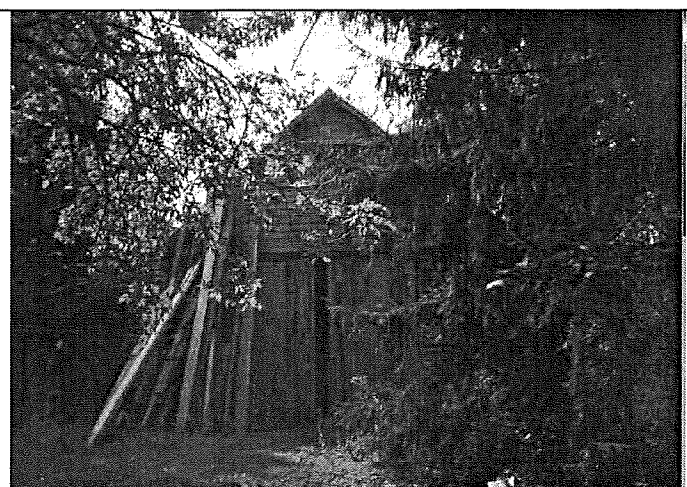
Circa: 1890	Condition: Poor	Integrity: Poor
-----------------------	---------------------------	---------------------------

Materials:	HISTORY:
Foundation: Concrete	House has been torn down and a new house is being built
Walls: Clapboard and slats	Only the corn crib remains
Roof: Wood shingles	
Porch:	<i>previous site = 1994</i>

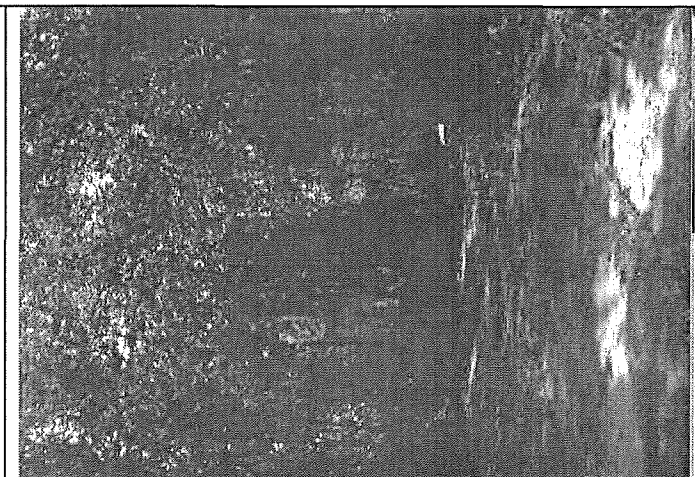
Circa: 1900	Condition: Poor	Integrity: Poor
-----------------------	---------------------------	---------------------------

Materials:	HISTORY:
Foundation: Concrete	Stone foundation from barn remains
Walls: Concrete	Obscured by overgrown vegetation
Roof: Concrete cone	
Porch:

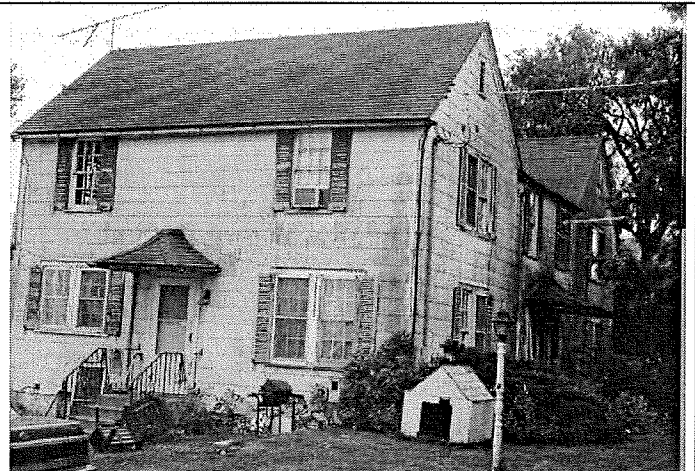
Roll No./Neg.No.: HH1 Surveyed by: LM &KD Date: 7-28-98

Circa: 1850 - 1865	Condition: Poor	Integrity: Good
------------------------------	---------------------------	---------------------------

Materials:	HISTORY:
Foundation: Concrete covered stone Walls: Asbestos Roof: Asphalt shingles Porch:	Original six-over-six windows, could be restored if asbestos removed

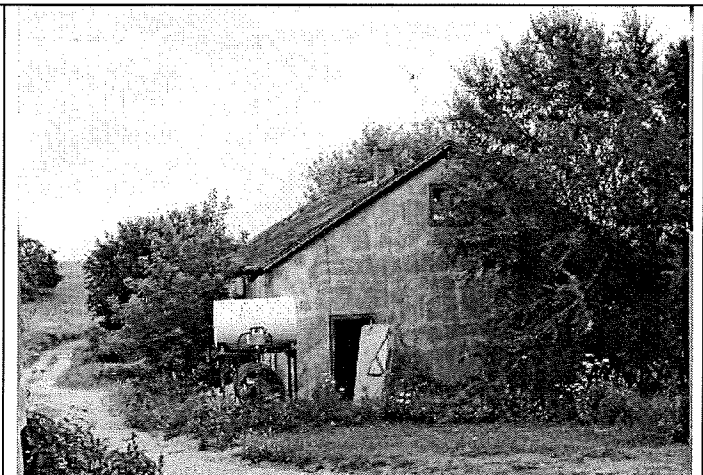
Roll No./Neg.No.: HH5 **Surveyed by:** LM &KD **Date:** 7-28-98

Circa: 1920 - 1930	Condition: Poor	Integrity: Poor
------------------------------	---------------------------	---------------------------

Materials:	HISTORY:
Foundation: Concrete	Single brick chimney, roof caving in
Walls: Stucco	Needs to be inspected for determination of age, could be older
Roof: Asphalt shingles	
Porch:
