**ROAD SAFETY STUDY**

**ACKMAN ROAD**  
**Haligus Road to Randall Road**

**September 2019**

McHenry County Division of Transportation

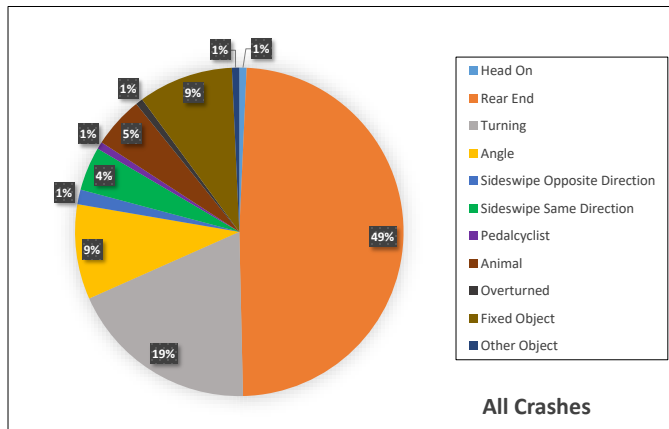
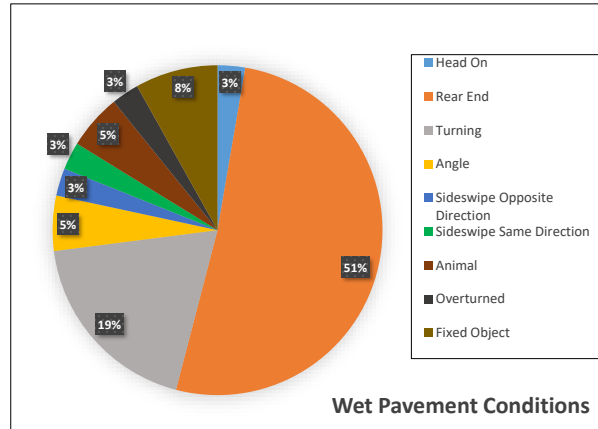
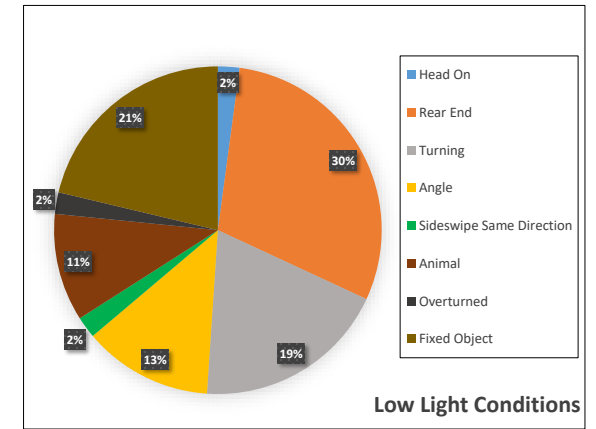
Number of Crashes						
Wet Pavement Conditions						
Crash Type	Fatal	A Injury	B Injury	C Injury	PDO	Total
Head On					1	1
Rear End				4	15	19
Turning			1	1	5	7
Angle					2	2
Sideswipe Opposite Direction					1	1
Sideswipe Same Direction					1	1
Animal					2	2
Overturned					1	1
Fixed Object					3	3
<b>Total</b>			<b>1</b>	<b>5</b>	<b>31</b>	<b>37</b>

Number of Crashes						
Low Light Conditions						
Crash Type	Fatal	A Injury	B Injury	C Injury	PDO	Total
Head On					1	1
Rear End			1	3	10	14
Turning			1	3	5	9
Angle				1	5	6
Sideswipe Same Direction					1	1
Animal				1	4	5
Overturned					1	1
Fixed Object			2		8	10
<b>Total</b>			<b>6</b>	<b>6</b>	<b>35</b>	<b>47</b>

- Rear ends are the predominant collision type, contributing to half of all the crashes within the study area. This trend is supported by observations of high speeds, unsafe headways, and stopped/queued traffic during the safety review field visit. For 77 of the total 139 crashes, aggressive driving behavior (speeding or following too closely) was listed as a contributing factor.

- A large proportion of the fixed object crashes occurred during low-light conditions.

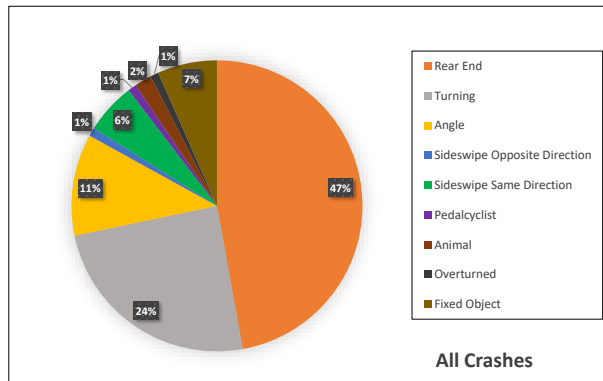
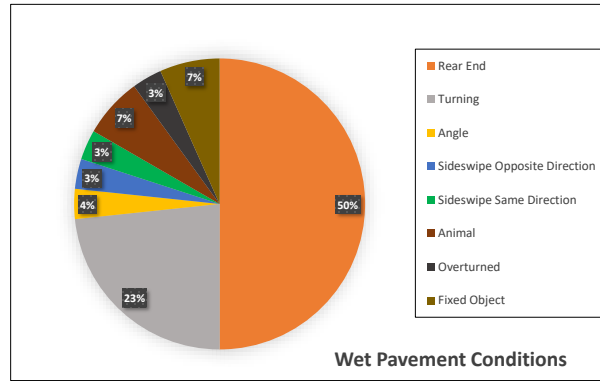
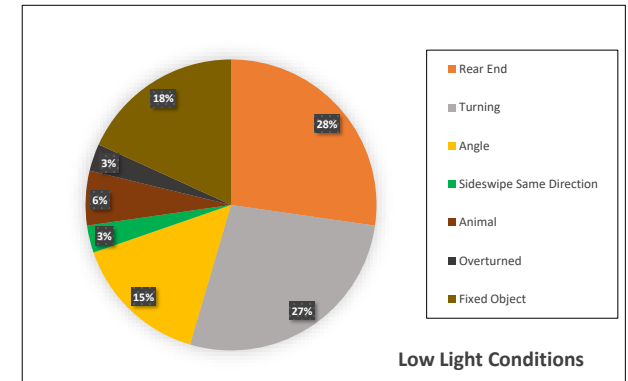
**Crash Data Summary  
(2014-2016)  
EXHIBIT 4A  
Intersection Crashes: Ackman Rd - Haligus Rd to Randall Rd**

Number of Crashes All Crashes						
Crash Type	Fatal	A Injury	B Injury	C Injury	PDO	Total
Rear End		1	1	7	41	50
Turning			2	6	18	26
Angle		2	2	2	6	12
Sideswipe Opposite Direction					1	1
Sideswipe Same Direction				1	5	6
Pedalcyclist		1				1
Animal					2	2
Overturned					1	1
Fixed Object			1		6	7
<b>Total</b>		<b>4</b>	<b>6</b>	<b>16</b>	<b>80</b>	<b>106</b>

Number of Crashes Wet Pavement Conditions						
Crash Type	Fatal	A Injury	B Injury	C Injury	PDO	Total
Rear End				3	12	15
Turning			1	1	5	7
Angle				1	1	1
Sideswipe Opposite Direction					1	1
Sideswipe Same Direction					1	1
Animal				2	2	2
Overturned				1	1	1
Fixed Object				2	2	2
<b>Total</b>			<b>1</b>	<b>4</b>	<b>25</b>	<b>30</b>

Number of Crashes Low Light Conditions						
Crash Type	Fatal	A Injury	B Injury	C Injury	PDO	Total
Rear End				2	7	9
Turning			1	3	5	9
Angle			1		4	5
Sideswipe Same Direction					1	1
Animal					2	2
Overturned					1	1
Fixed Object			1		5	6
<b>Total</b>			<b>3</b>	<b>5</b>	<b>25</b>	<b>33</b>

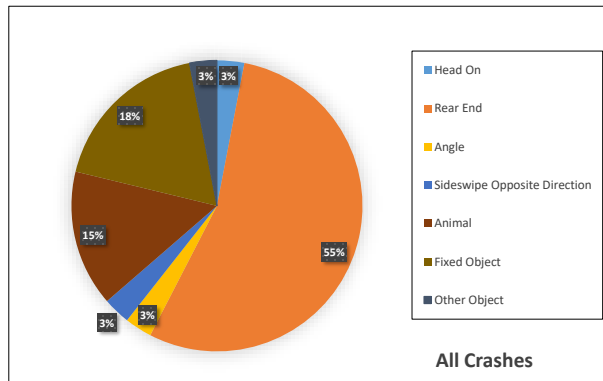
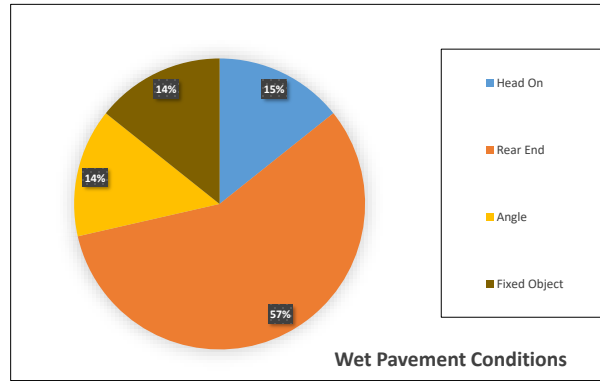
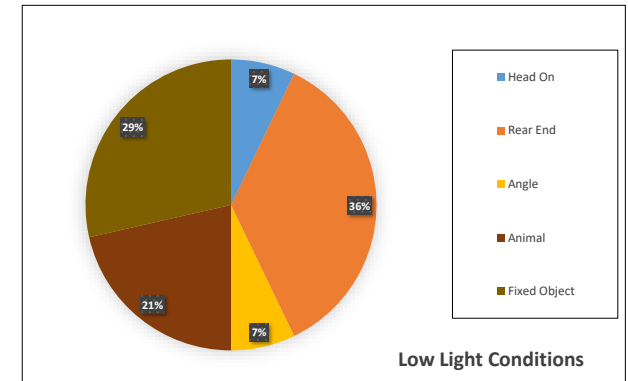
**Crash Data Summary  
(2014-2016)  
EXHIBIT 4B  
Segment Crashes: Ackman Rd - Haligus Rd to Randall Rd**

Number of Crashes All Crashes						
Crash Type	Fatal	A Injury	B Injury	C Injury	PDO	Total
Head On					1	1
Rear End			2	2	14	18
Angle					1	1
Sideswipe Opposite Direction			1			1
Animal			1		4	5
Fixed Object	1		1		4	6
Other Object					1	1
<b>Total</b>	<b>1</b>		<b>5</b>	<b>2</b>	<b>25</b>	<b>33</b>

Number of Crashes Wet Pavement Conditions						
Crash Type	Fatal	A Injury	B Injury	C Injury	PDO	Total
Head On					1	1
Rear End				1	3	4
Angle					1	1
Fixed Object					1	1
<b>Total</b>				<b>1</b>	<b>6</b>	<b>7</b>

Number of Crashes Low Light Conditions						
Crash Type	Fatal	A Injury	B Injury	C Injury	PDO	Total
Head On					1	1
Rear End			1	1	3	5
Angle					1	1
Animal			1		2	3
Fixed Object			1		3	4
<b>Total</b>			<b>3</b>	<b>1</b>	<b>10</b>	<b>14</b>
