McHenry County

Rural Survey

1998-1999

***Completion Report
&
Data Analysis***

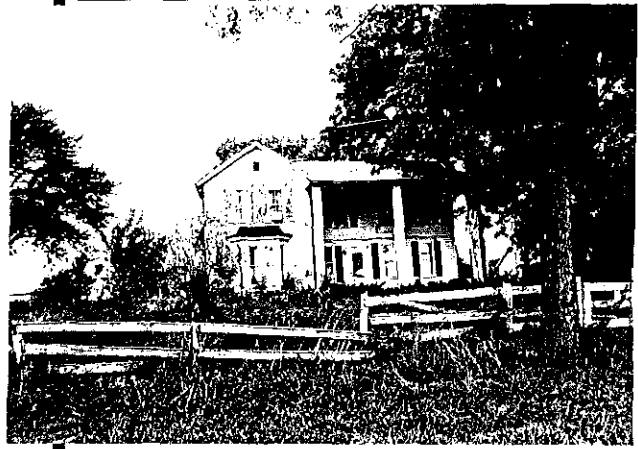
Roll No./Neg.No.: MM/16 Surveyed by: LM & KD Date: 7-28-98

Circa: 1880 - 1910	Condition: Fair	Integrity: Poor
------------------------------	---------------------------	---------------------------

Materials:	HISTORY:
Foundation: Stone Walls: Clapboard Roof: Asphalt shingle Porch: Front with columns	20 rooms Front half is the original, only the cement foundation of the barn remains Previous site = 1989

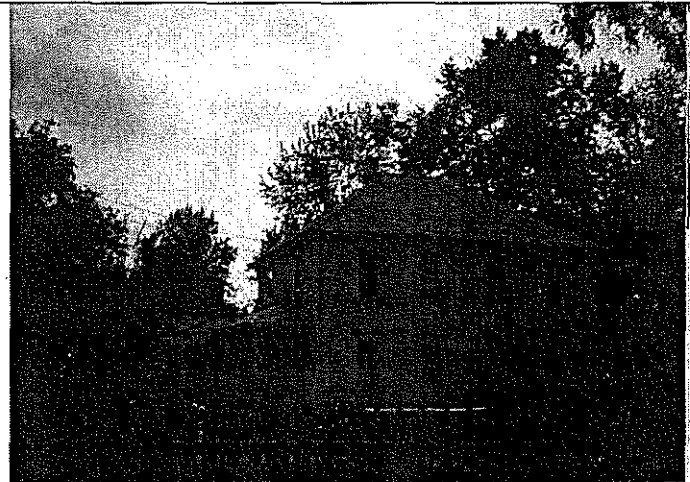
Roll No./Neg.No.: NN/21

Circa: 1860-1880	Condition: Good	Integrity: Good
----------------------------	---------------------------	---------------------------

Materials:	HISTORY:
Foundation: Stone	
Walls: Clapboard	
Roof: Asphalt shingle	
Porch: Open with original corner brackets and posts	
	Ornamental corbels in the eaves
	Previous site = 1955

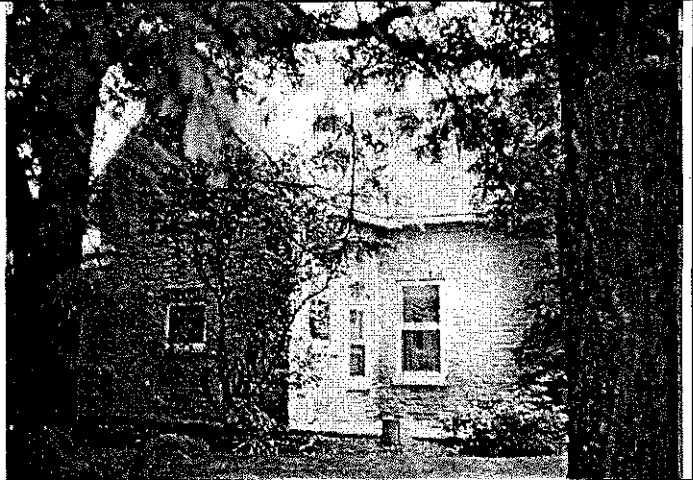
Roll no./Neg. PP/18 & PP19 side & PP21 rear Surveyed by: LM & KD Date: 8/24/98

Materials:	HISTORY:		
Foundation: Brick	"Prescott Whittemore House" circa 1841		
Walls: Limestone	Plaqued by McHenry County Historical Society		
Roof: Asphalt shingles	Lace edging along eaves – Carpenter Gothic features		
Porch:	Previous site = 1736

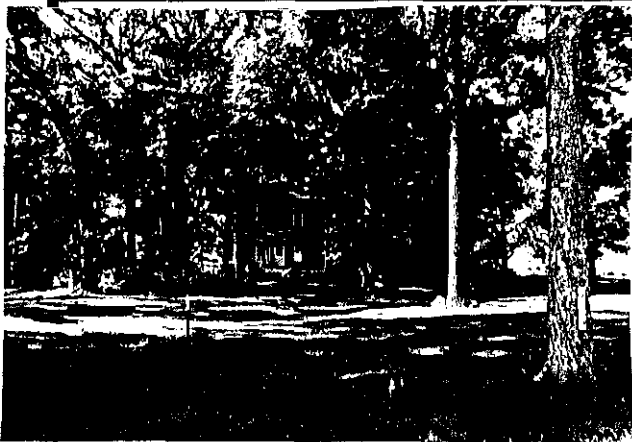
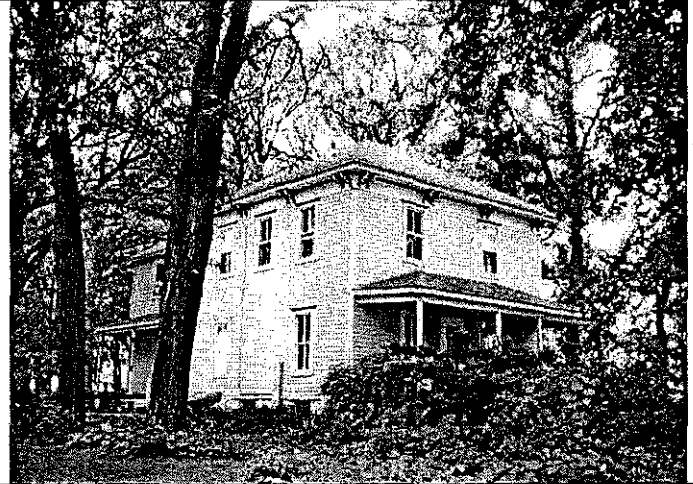
Roll no./Neg: PA/3

Materials:	HISTORY:
Foundation: Stone	Original portion has excellent integrity
Walls: Clapboard	Original 2-over-2 windows and paired corbels in eaves
Roof: Asphalt shingle	
Porch: Front and side both open	Previous survey = site 1594

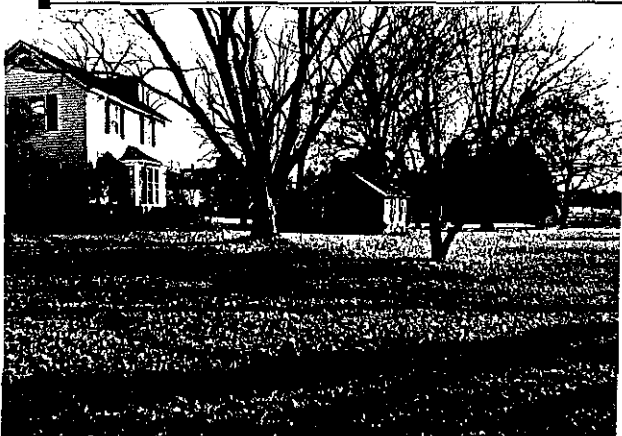
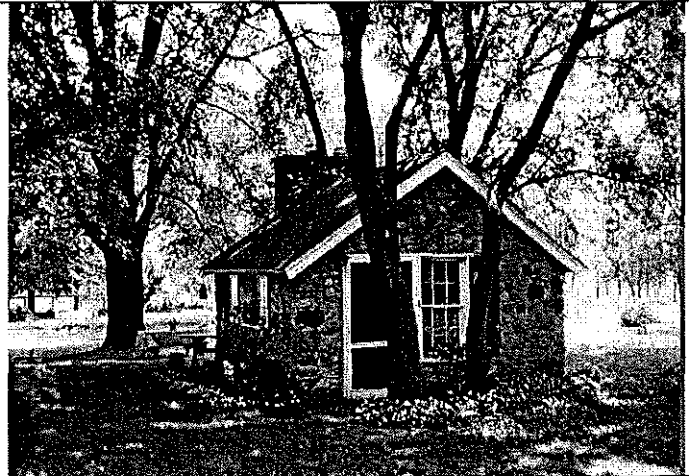
Roll No./Neg.No.: W29

Materials:	HISTORY:
Foundation: Stone	Large stone chimney
Walls: Fieldstone	New brick inside hearth
Roof: Asphalt shingle	Owner suggests not a smokehouse but one of the original houses in land track grant
Porch:

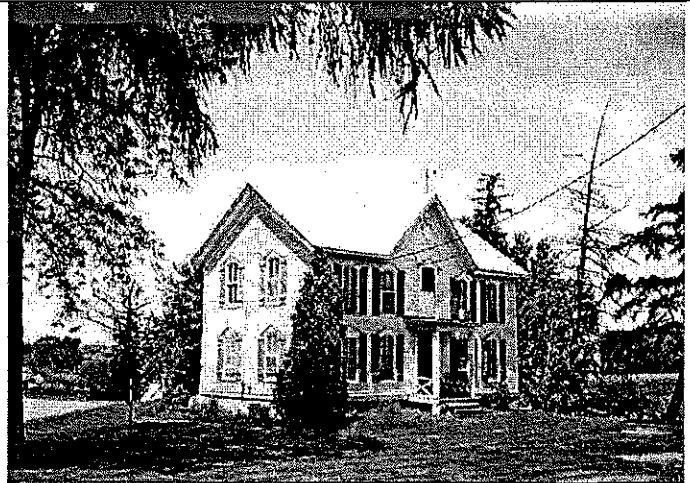
Materials:	HISTORY:
Foundation: Poured Walls: Clapboard Roof: Asphalt shingle Porch: Front stoop	Unique shutters, green with cutout diamonds, moldings and front decorative piece (old attic window), peaked windows, addition has been converted to apartments. <i>Original two-over-two windows.</i> <i>Unique to this area</i> <i>for both it's excellent integrity & for this type of layout.</i> Previous site = 2492

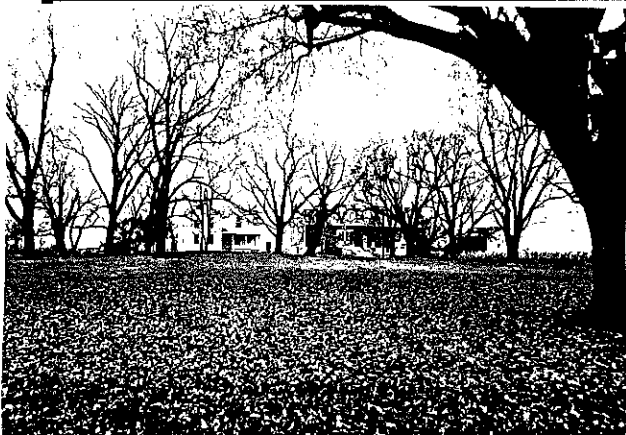
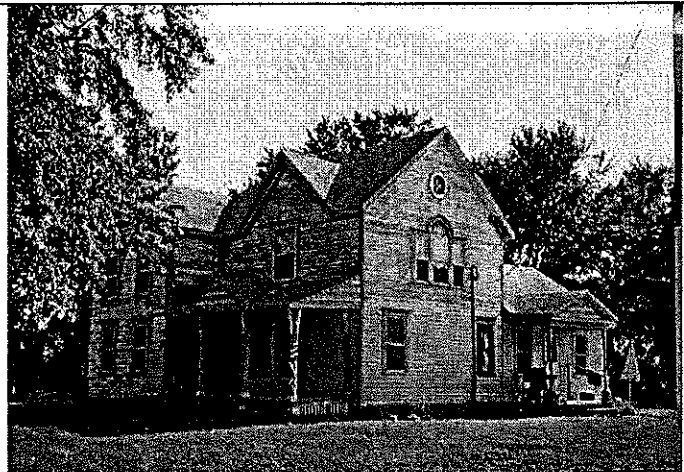
Roll No./Neg.No.: AA22

Materials:	HISTORY:
Foundation: Poured concrete	Linked with PIN: 14-10-300-002
Walls: Clapboard	Moldings around windows.
Roof: Asphalt shingle	Paladin window on end
Porch: Front with columns	<i>previous site = 4689</i>

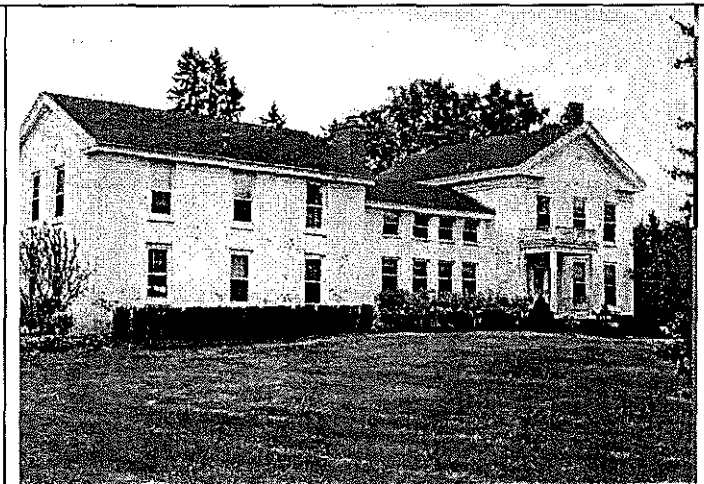
Roll No./Neg.No.: U1 Surveyed by KD&LM Date: 7-12-98

Materials:	HISTORY:
Foundation: Stone	Previous survey says house dates from 1837
Walls: Brick	Owner of residence is the developer for surrounding subdivision
Roof: Asphalt shingle	<i>In very good condition</i>
Porch: Rear enclosed	Some alterations to middle section (new windows)
	Used to belong to the Holcomb family buried in close cemetery
	Previous site = 2170

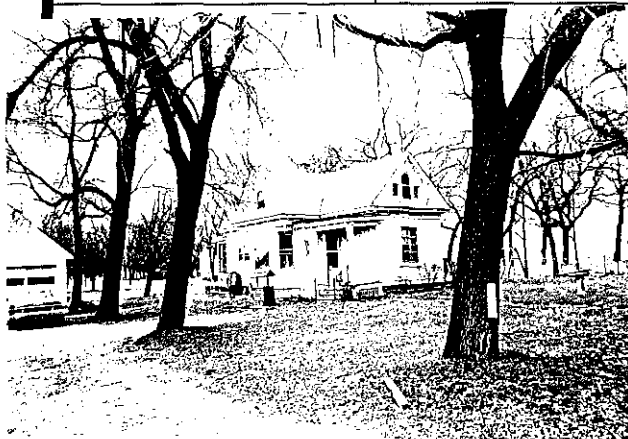
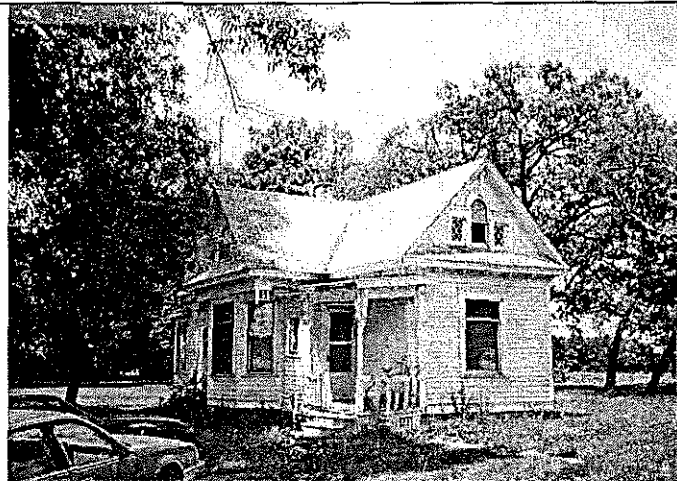
Roll No./Neg.No.: AA15

PIN 14-22-126-010 (Previous site 4687) This **Queen Anne cottage** is in poor condition and is continually getting worse. To bad someone doesn't save this house.

Materials:	HISTORY:
Foundation: Block	Is being demolished by abuse. In very bad shape.
Walls: Clapboard	
Roof: Asphalt shingle	
Porch:	
	Now home of "Greg's Auto Service." Decorative trellises and carved wood in eaves, central brick chimney.
	This one should have been saved, but might be in too bad of shape, much worse condition then when this photo was taken.
	Previous site = 4687

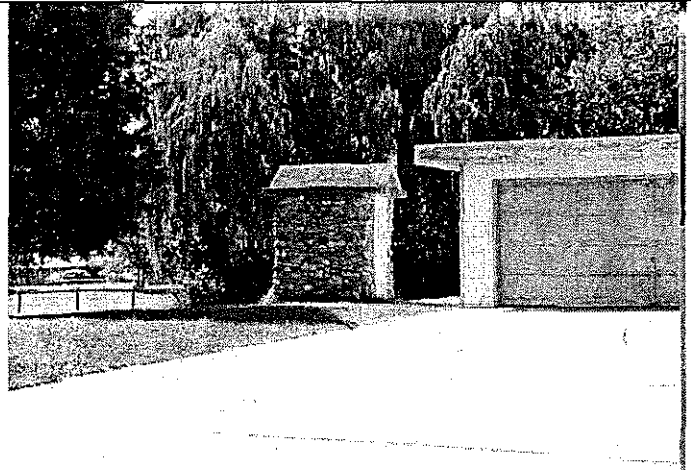
Roll No./Neg.No.: CL 6/2 **Surveyed by:** CL **Date:** 7-20-98

Materials:	HISTORY: Fieldstone Gable roof-thatch
Foundation:	
Walls: Fieldstone	
Roof: Thatch	
Porch:

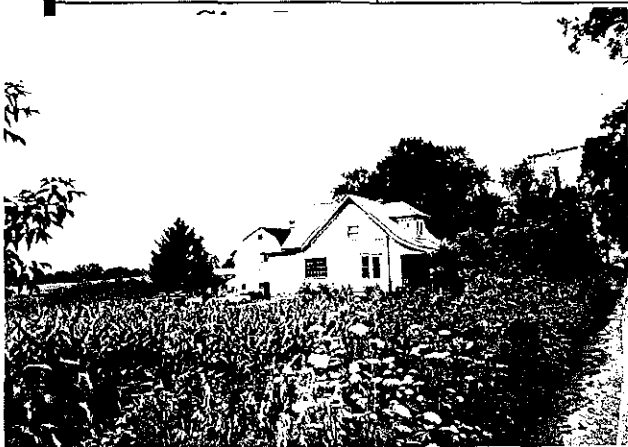
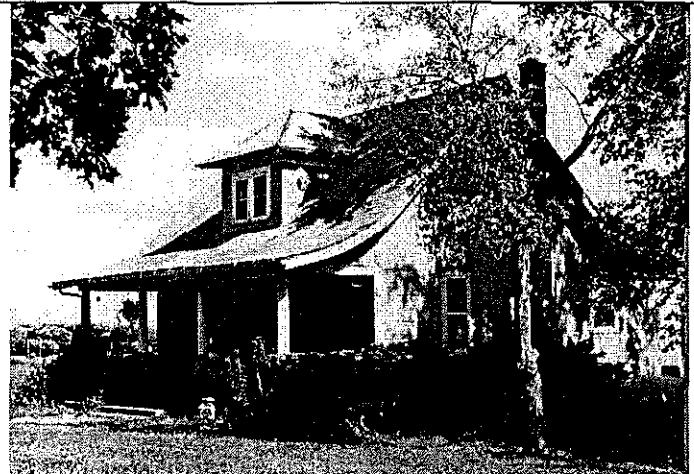
Materials:	HISTORY:
Foundation: Block	Dormer with hipped roof & <i>tiny diamond windows on sides</i>
Walls: Asbestos	
Roof: Asphalt shingle	
Porch: Front with columns	
	Brick chimney
	Swayed extension over porch
	Previous survey site = 2152

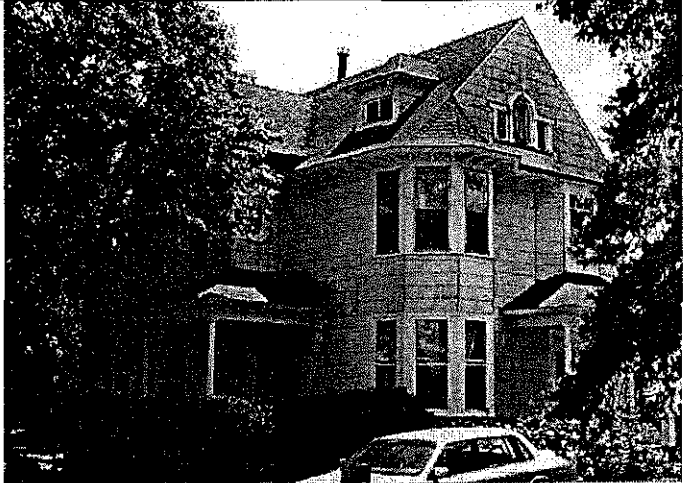
Materials:	HISTORY:
Foundation: Stone	Moldings over front door and 2 nd floor window in front
Walls: Asbestos	Main frame is a gable with ornamental overhang
Roof: Asphalt shingle	Arched decorative windows; very ornate moldings
Porch: TWO Porches with hipped roof and columns	Dormer windows on 3 rd floor and Paladion window in gable
	Decorative braces under roof overhang
	Decorative wood shingle remain on rear wall
	2 story bay forms a pseudo-turret shape
	Previous site = 2082

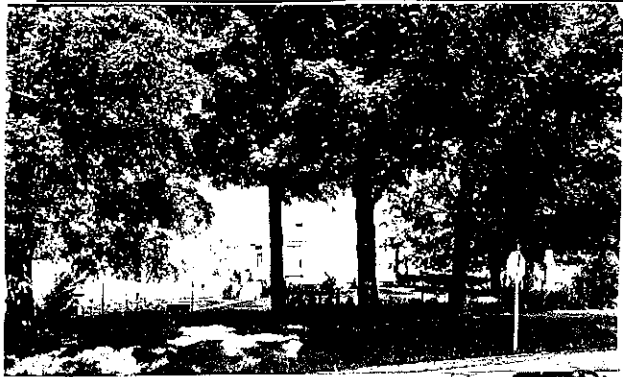
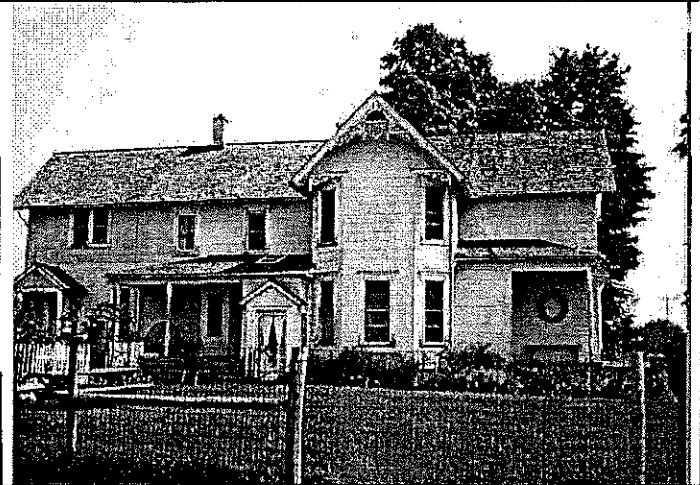
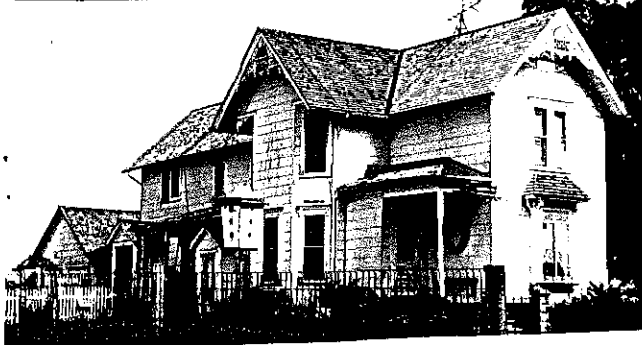
Tenant says that this farm and one across the street 09-16-400-016 are soon to knocked down.
Farm dates from 1840's.

Previous site = 2079

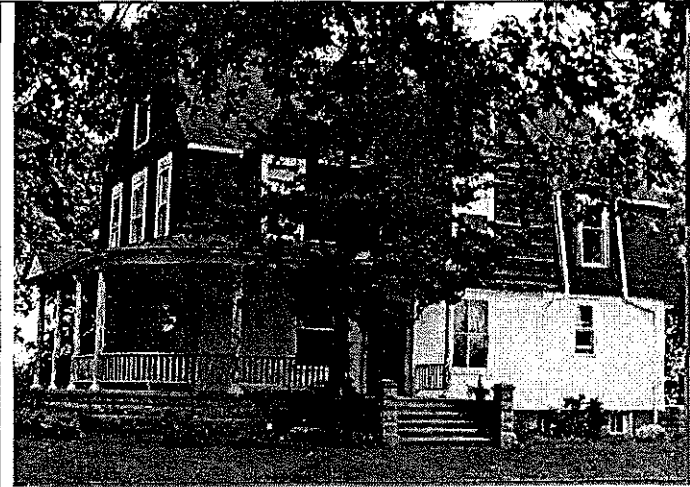
Materials:	HISTORY:
Foundation: Stone	From aerial, it appears that a large barn on eastern side of farmstead was removed. 2 ½ story residence; gambrel roof with intersecting gable Curved, columned, 2-sided porch Foundations of two demolished barns remain Previous site = 2078
Walls: Clapboard and asbestos	
Roof: Asphalt shingle	
Porch: Wrap around

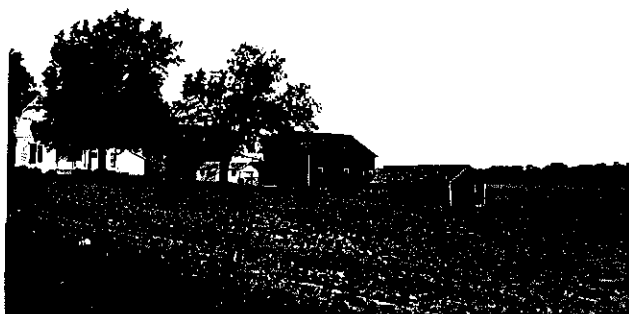
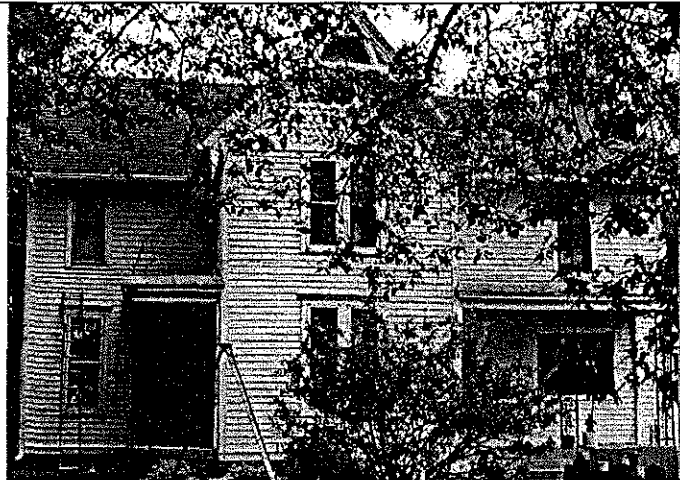
PIN 09-19-400-005 (Previous site 161) This **Queen Anne house** is in good condition with only minor alterations to the porches that could be restored.

Materials:	HISTORY:
Foundation: Stone	One end chimney
Walls: Clapboard	Impossible to get a clear picture because of huge trees
Roof: Asphalt shingle	Queen Anne style ornament on gables
Porch: <i>Redone</i>	<i>Previous survey = 161</i>
