STRUCTURE NUMBER: 056-3071

INSPECTION TYPE: 24 Month Routine

DATE: 05/06/2020

2020 HARTLAND TOWNSHIP BRIDGE INSPECTION PROGRAM

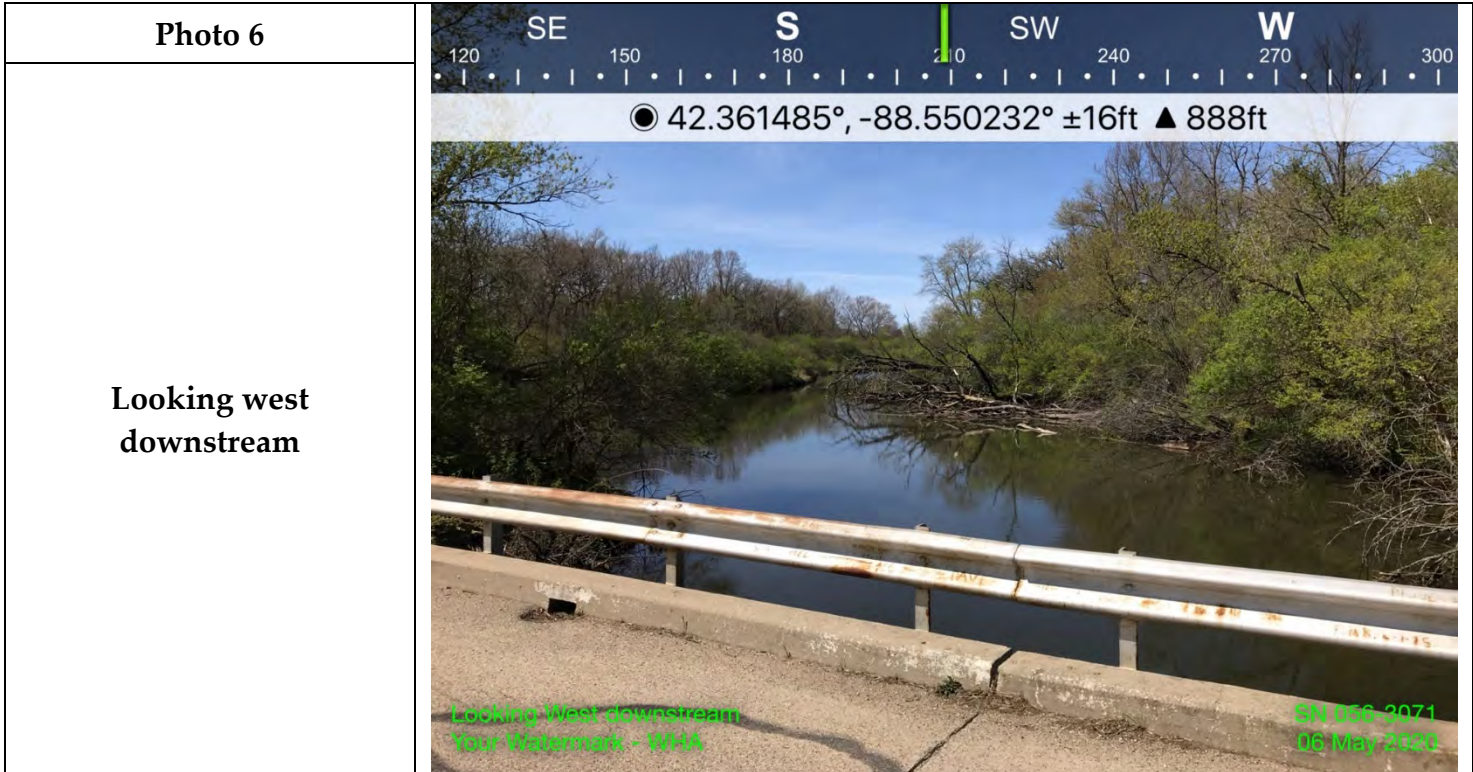
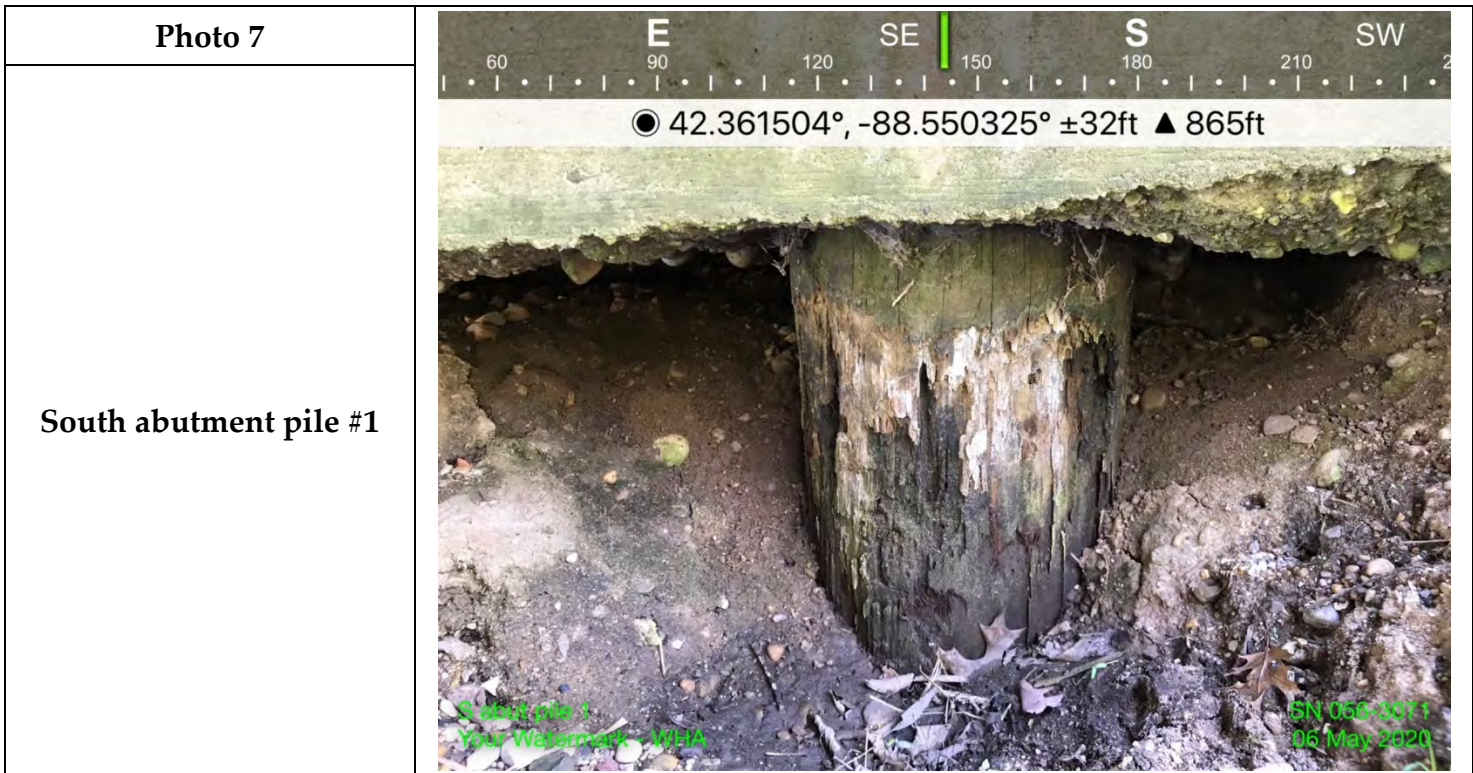
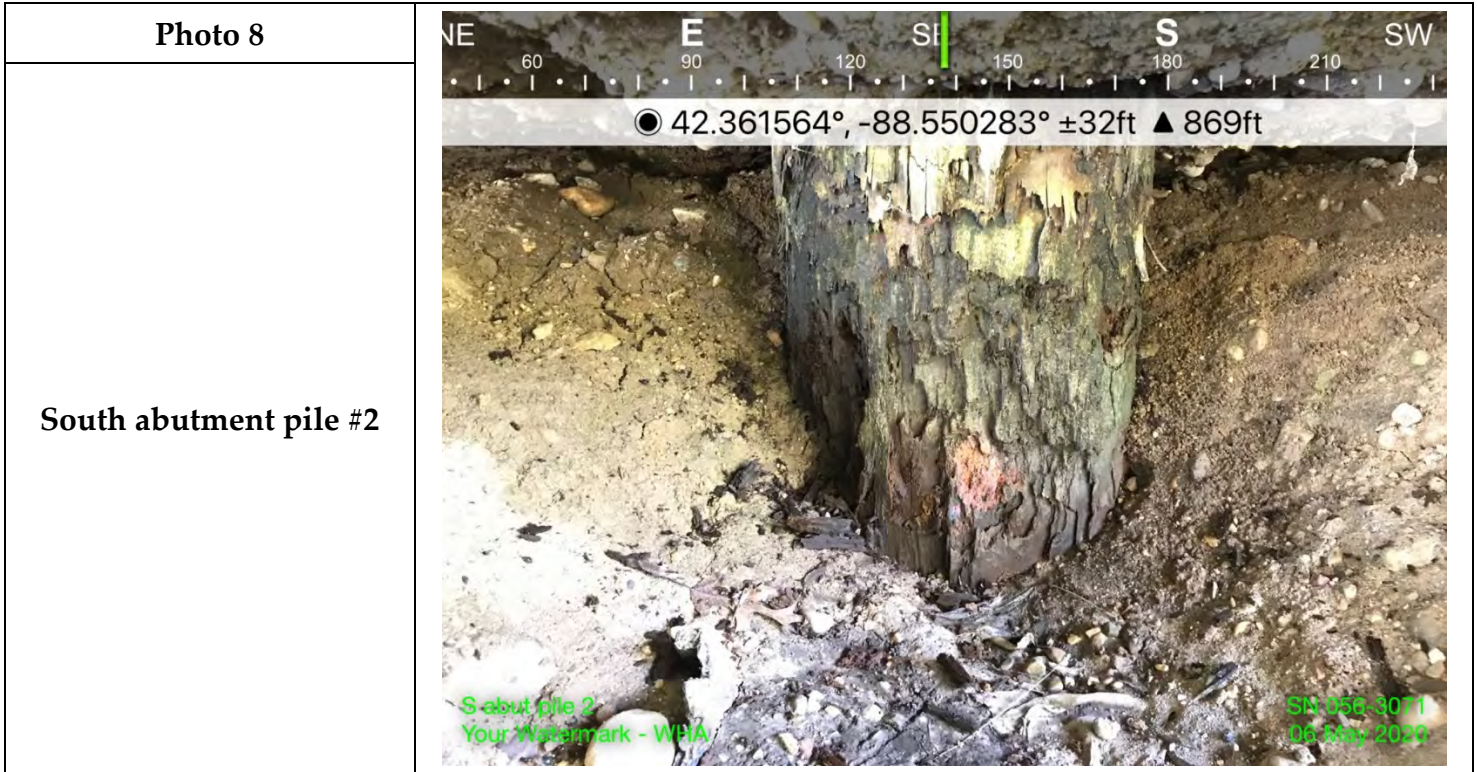
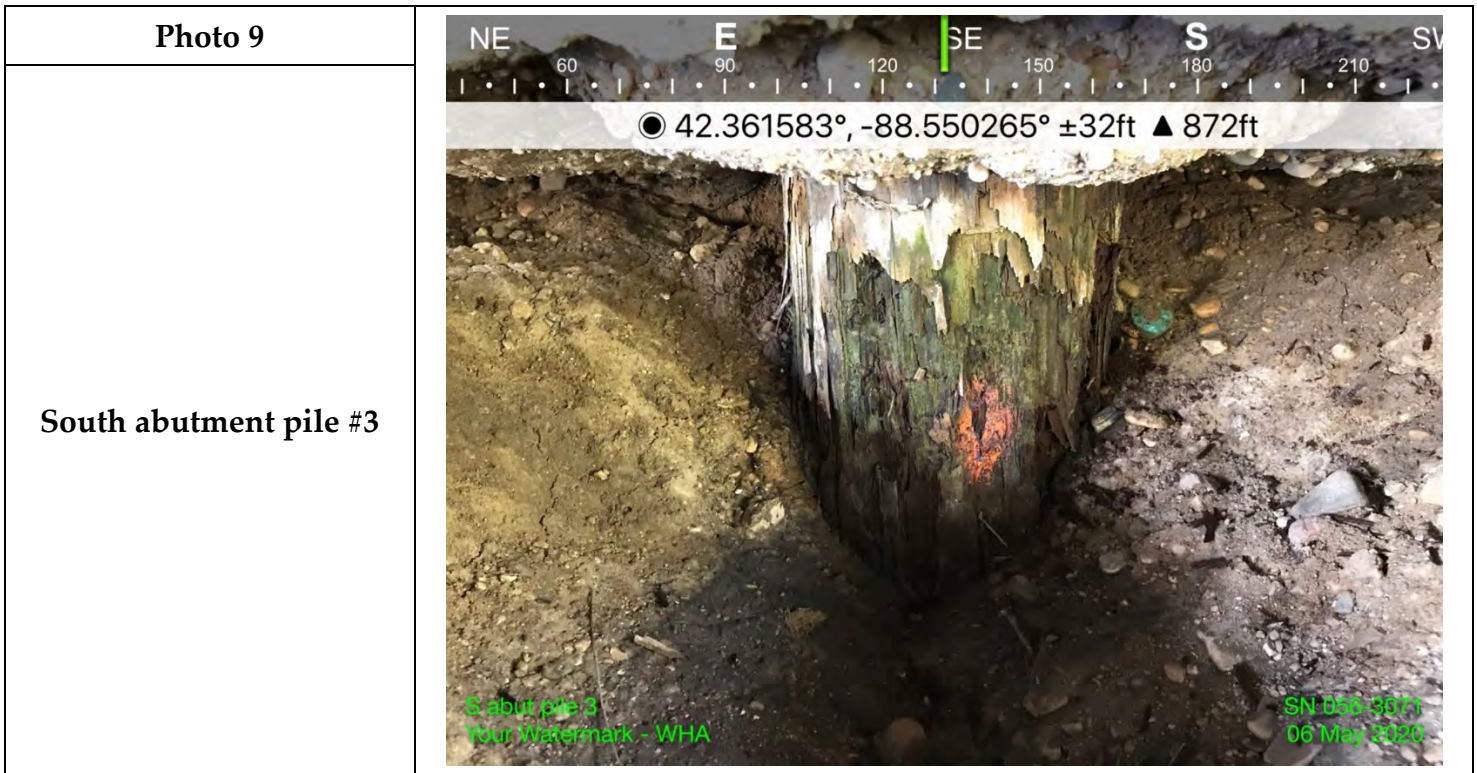
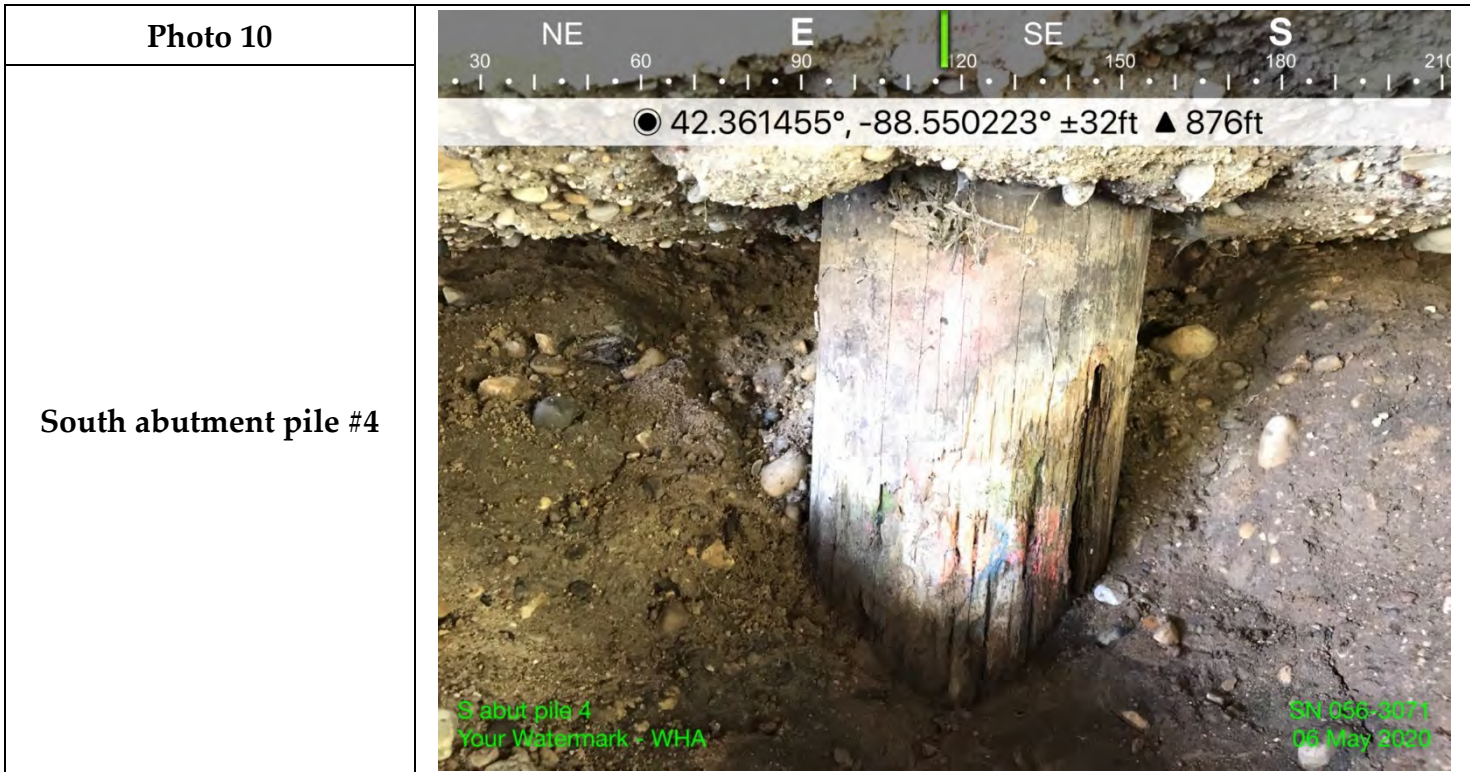
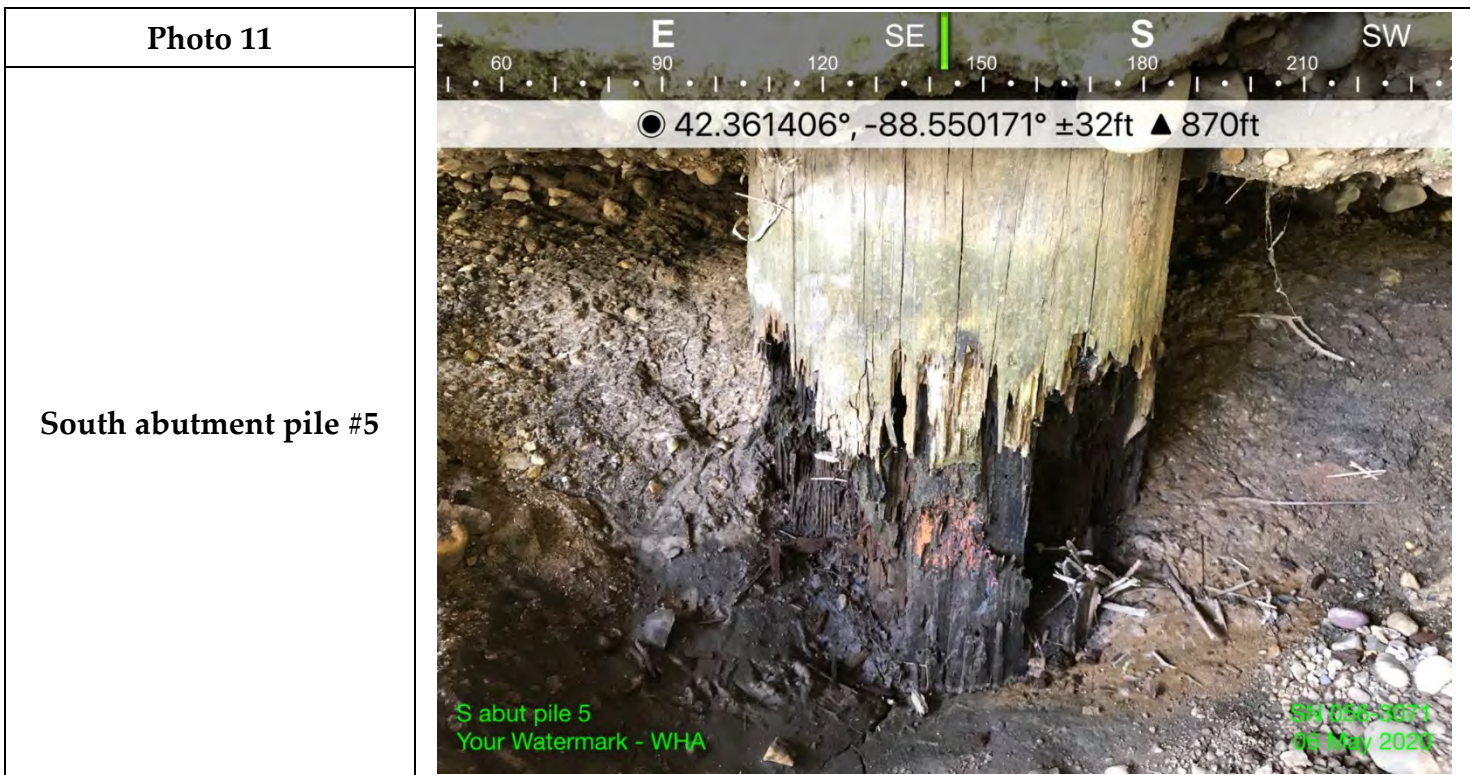
Bridge Railing Appraisal:	<input type="text" value="2"/>	Doesn't Meet Standards		Items 58 & 59 - Significant keyway leakage. Minor spalls in several beams due to inadequate concrete cover. Item 60 - Severe timber pile deterioration and section loss both abutments.		
Approach Guardrail:	<input type="text" value="111"/>	Does Not Exist	<input type="text" value="Does Not Exist"/>	South abut pile 1 - soft estimate 10% section lo		
Pier Navig Protection:	<input type="text" value="N"/>	N/A

Monitor timber pile deterioration 7 - 18
