McHenry County

Rural Survey

Algonquin Township

FIELD DATA SHEETS

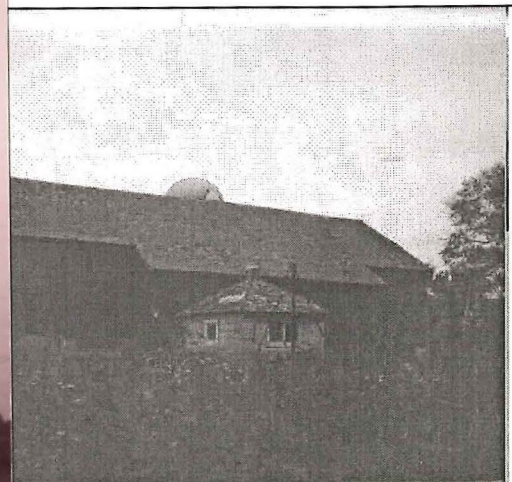
Circa: 1890	Condition: Poor	Integrity: Poor
-----------------------	---------------------------	---------------------------

Materials:	HISTORY:
Foundation: Concrete Walls: Vertical plank Roof: Wood shingles Porch:	Ramped transverse aisle, there is an extension in the middle of the barn of about 4 feet

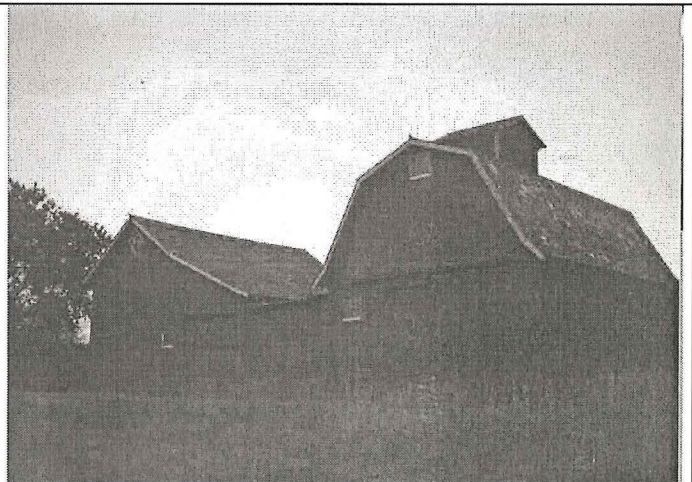
Circa: 1880 - 1900	Condition: Poor	Integrity: Good
------------------------------	---------------------------	---------------------------

Materials:	HISTORY: Composite structure, gambrel part has clapboard, rear of gambrel part is a corn crib; gambrel has a cupola with gable roof (central)
Foundation: Concrete	
Walls: Vertical plank	
Roof: Wood shingles	
Porch:

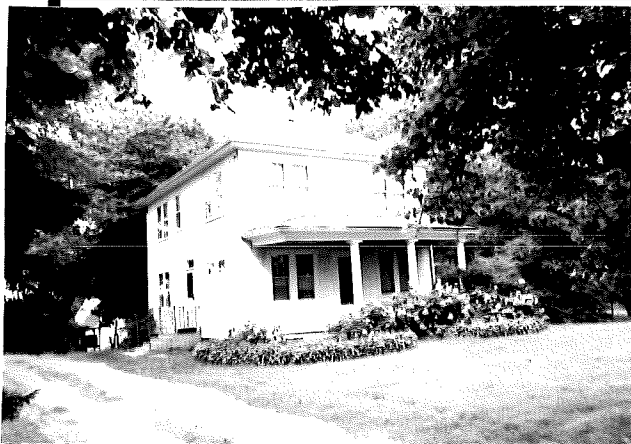
Circa: 1930	Condition: Good	Integrity: Poor
-----------------------	---------------------------	---------------------------

Materials:	HISTORY:
Foundation: Poured	Hipped roof
Walls: Asbestos	Original columns intact
Roof: Asphalt shingles	Original 3 over one windows intact
Porch: Front w/ pillars	Suitable for restoration if asbestos siding is removed
	Previous site = 1995

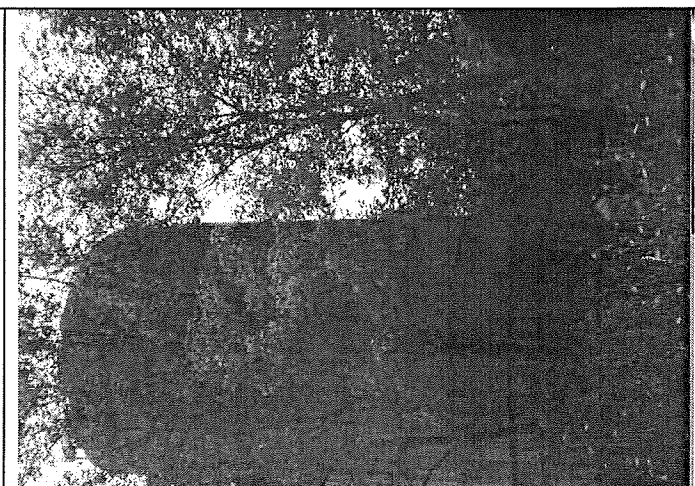
Circa: 1920	Condition: Poor	Integrity: Poor
-----------------------	---------------------------	---------------------------

Materials:	<p>HISTORY:</p> <p>This seems to have been overlooked on previous survey, but it could be one of the "1986" sites - the one possible linked with 19-01-300-001 or it could be site 1996 from survey card, which has no corresponding map point.</p> <p>Barn foundation remains next to silo, has been abandoned</p> <p><i>Previous site = 1996</i></p>
Foundation:	
Walls: Staved concrete	
Roof: Metal dome	
Porch:

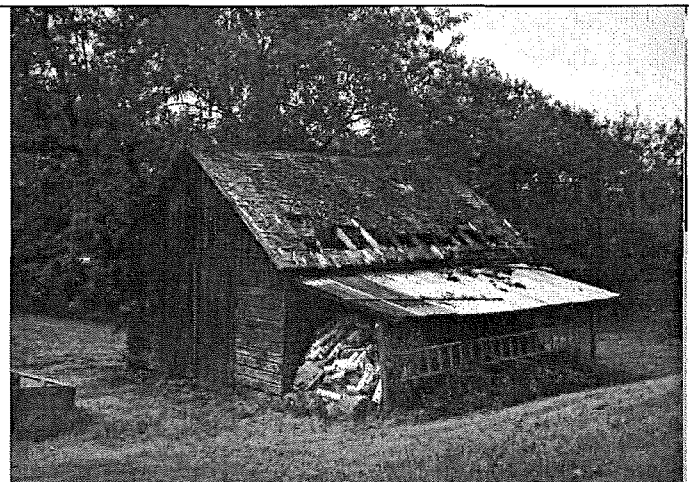
Circa: 1900	Condition: Poor	Integrity: Poor
-----------------------	---------------------------	---------------------------

Materials:	HISTORY:
Foundation: Raised on blocks	In state of bad disrepair
Walls: Horizontal wood slats	Will cave in soon if roof not fixed
Roof: Wood shingles	
Porch:

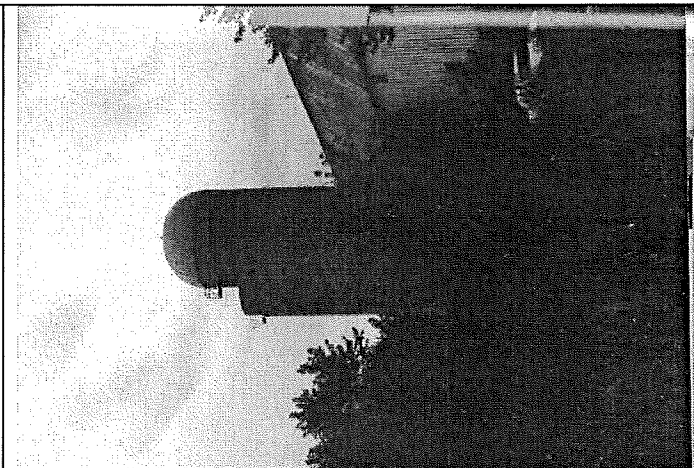
Circa: 1920	Condition: Poor	Integrity: Good
-----------------------	---------------------------	---------------------------

Materials:	HISTORY:
Foundation: Concrete	Both with viewing platforms
Walls: Concrete stave	One with ladders
Roof: Metal dome-1 missing	Side flanking to barn
Porch:

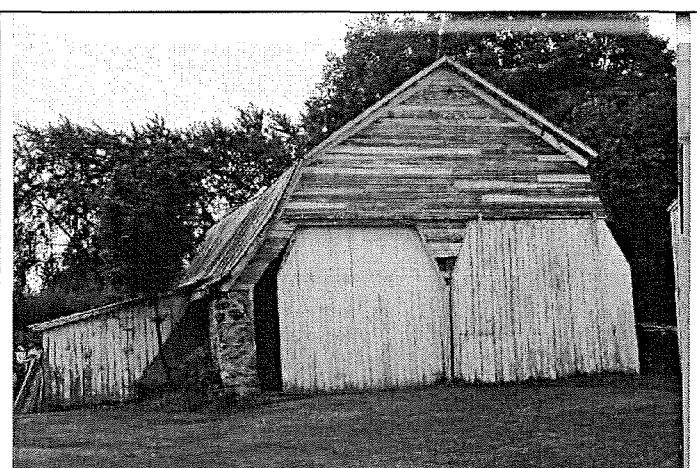
Circa: 1900	Condition: Poor	Integrity: Poor
-----------------------	---------------------------	---------------------------

Materials:	HISTORY:
Foundation: Stone Walls: Stone and clapboard Roof: Metal Porch:	This structure is coming down

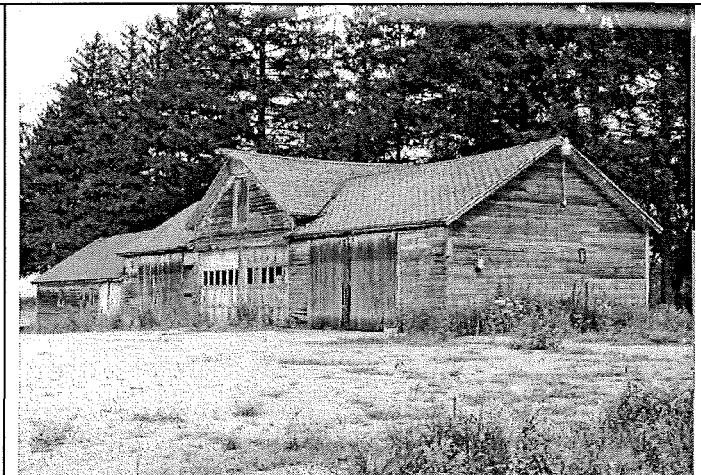
Roll No./Neg.No.: V/19

Circa: 1920 - 1940	Condition: Poor	Integrity: Good
------------------------------	---------------------------	---------------------------

Materials:	HISTORY:
Foundation: Concrete	Intersecting gables with extending gable addition on one end
Walls: Vertical plank and beveled clapboard	
Roof: Asphalt shingles	
Porch:	
	Multiple up and over and sliding doors
	Hay loft central front gable section

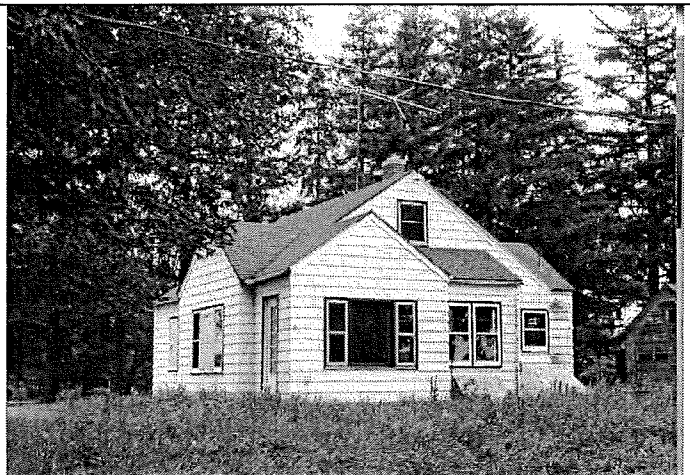
Roll No./Neg.No.: V/21

Circa: Post 1945	Condition: Good	Integrity: Poor
----------------------------	---------------------------	---------------------------

Materials:	HISTORY:
Foundation: Concrete	This may be 12010 Randall, central chimney Several gabled additions
Walls: Aluminum siding	
Roof: Asphalt shingles	
Porch:

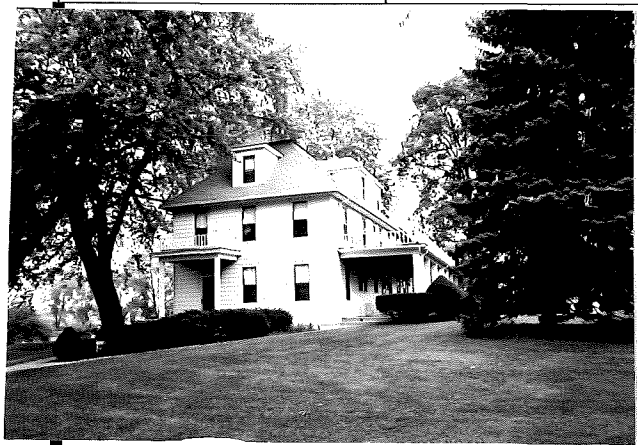
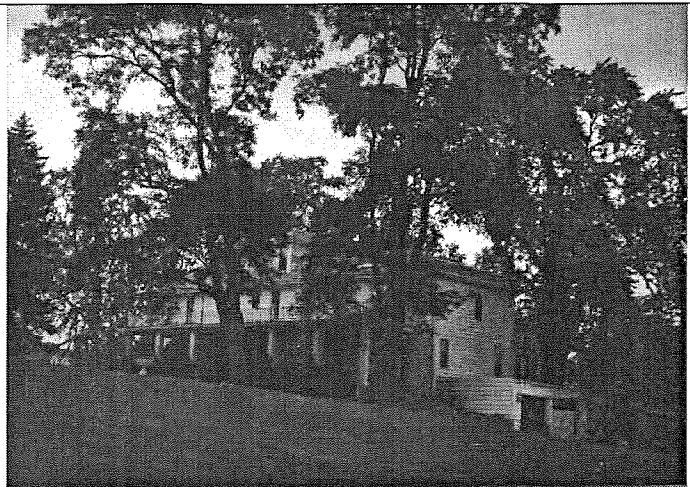
Roll No./Neg. No.: NN/10

Circa:	Condition:	Integrity:
1880 - 1910	Good	Poor

Materials:	HISTORY:
Foundation: Concrete block and sandstone Walls: Aluminum siding Roof: Asphalt shingles Porch: Huge front, with columns, balcony above the roof	Large structural, addition has walkout basement 3 chimneys Previous survey = 1985

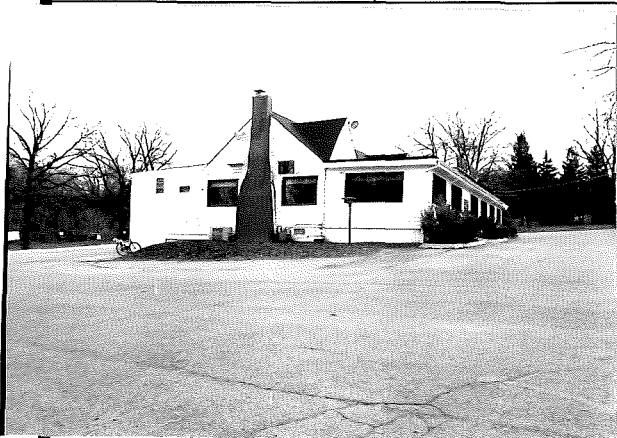
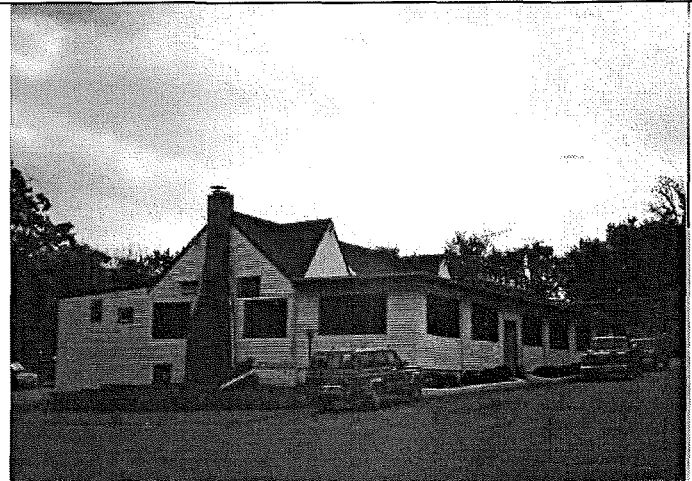
Roll No./Neg.No.: NN13

Function: Tavern	Vernacular Type: Cape cod	Arch. Style:	Alterations: Major addition to front and rear
Circa: 1910-1945	Condition: Good	Integrity: Poor	
Source: 1995 Sidwell map	Landmark Evaluation: TBD		
Architect/Builder: Unknown	Individual:	Farmstead:	National Register: Local:
	Criteria: /14	(See reverse side of criteria listing)	
Materials: Foundation: Concrete Walls: Clapboard Roof: Asphalt shingle Porch:	HISTORY: Brick chimney at one end Major restaurant addition "River Bend" The original was a cape cod style with dormers on the front second story

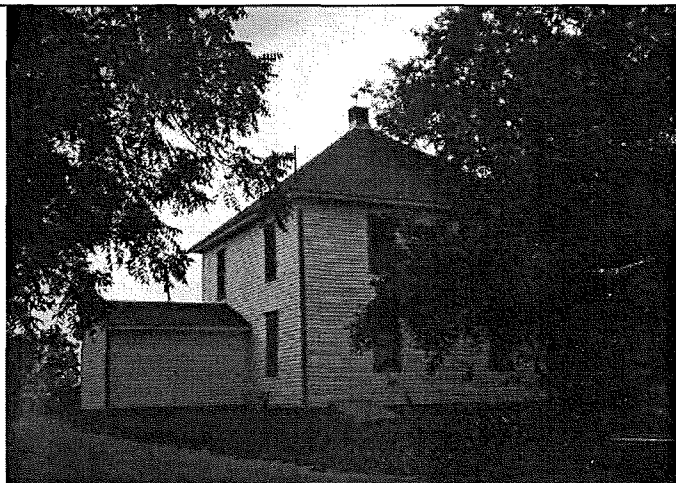
Roll No./Neg.No.: NN16

Circa: 1907	Condition: Good	Integrity: Excellent
-----------------------	---------------------------	--------------------------------

Materials:	HISTORY:
Foundation: Stone	Previous survey notes that barn was torn down by MCCD, central brick chimney.
Walls: Clapboard	
Roof: Asphalt shingle	
Porch:	
	Previous site = 1984

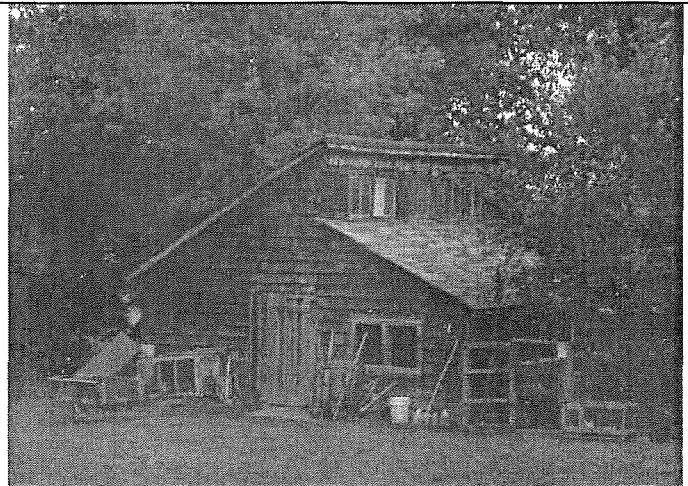
Roll No./Neg.No.: NN14

Circa: 1900 - 1920	Condition: Poor	Integrity: Good
------------------------------	---------------------------	---------------------------

Materials:	HISTORY: Chicken coop with broken ridge and clerestory windows
Foundation: Concrete	
Walls: Wood shingles	
Roof: asphalt	
Porch:

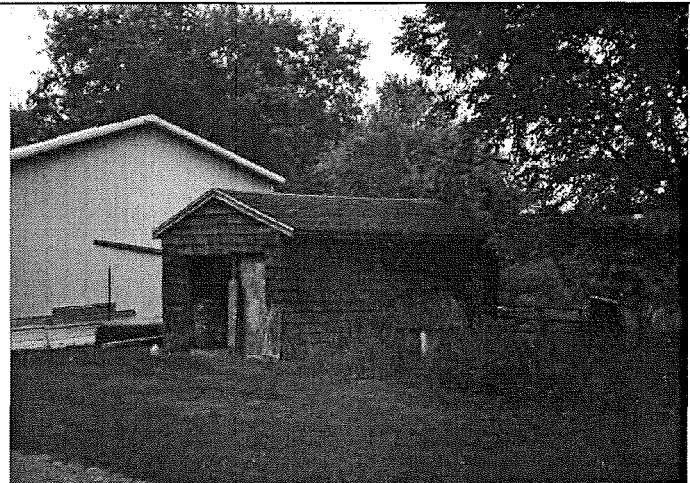
Roll No./Neg.No.: NN15

Circa: 1910 - 1930	Condition: Poor	Integrity: Good
------------------------------	---------------------------	---------------------------

Materials:	HISTORY:
Foundation: Raised on concrete blocks	Door is missing
Walls: Wood shingles	Gable roof
Roof: asphalt	
Porch:

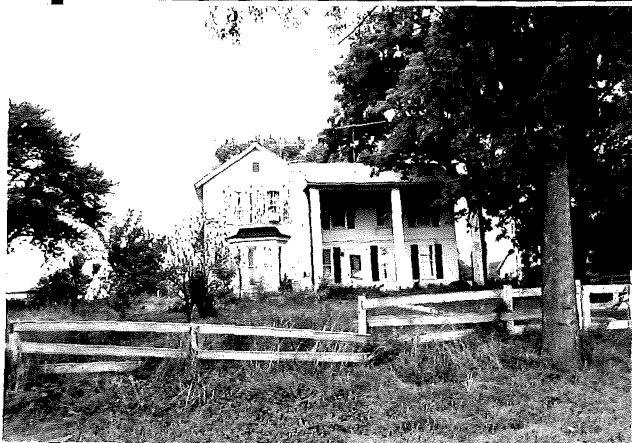
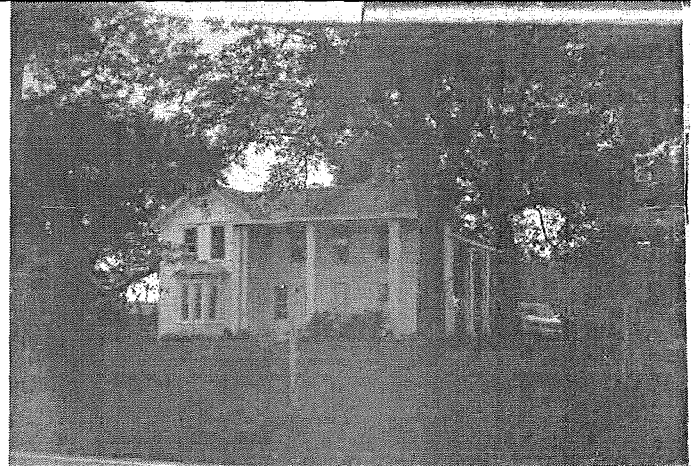
Roll No./Neg.No.: MM/16

Circa: 1880 - 1910	Condition: Fair	Integrity: Poor
------------------------------	---------------------------	---------------------------

Materials:	HISTORY:
Foundation: Stone	20 rooms
Walls: Clapboard	Front half is the original, only the cement foundation of the barn remains
Roof: Asphalt shingle	
Porch: Front with columns	
	Previous site = 1989

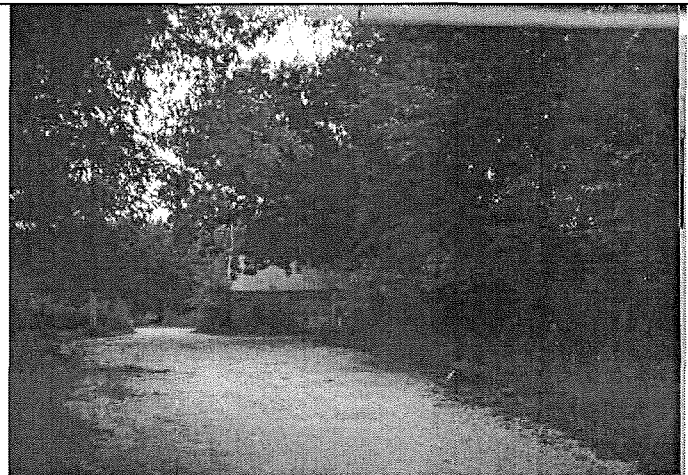
Circa: 1910	Condition: Fair	Integrity: Good
-----------------------	---------------------------	---------------------------

Materials:	HISTORY:
Foundation: Concrete	2 up-and-over doors
Walls: Clapboard	Obscured by overgrowth
Roof: Asphalt shingle	
Porch:

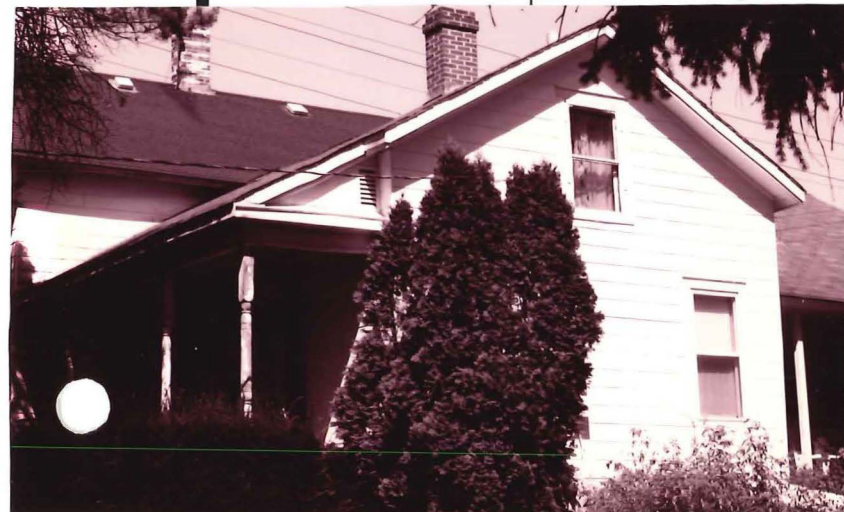
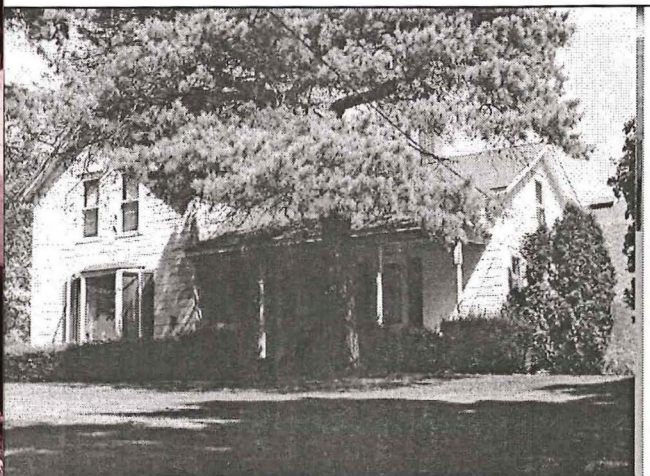
Function:	Vernacular Type:	Arch. Style:	Alterations:
Residence	Upright and wing		Major addition to rear Replacement windows Front bay window added

Circa: 1850 - 1870	Condition: Good	Integrity: Good
------------------------------	---------------------------	---------------------------

Materials:	HISTORY:
Foundation: Stone and concrete	Additions in rear
Walls: Asbestos	2 brick chimneys
Roof: Asphalt shingle	An old stone foundation remains near the house of another outbuilding
Porch: front	
	Previous survey = 1973

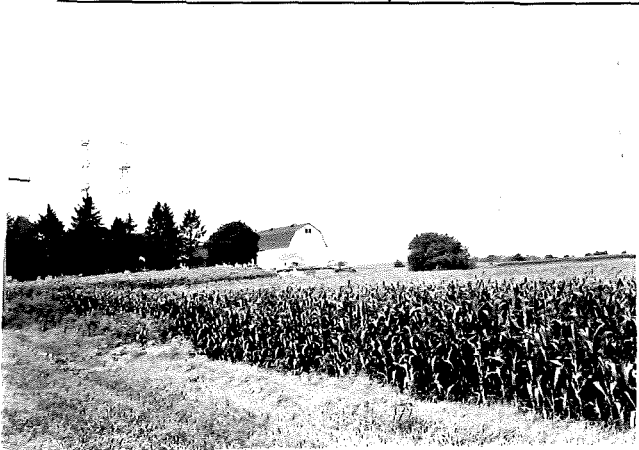
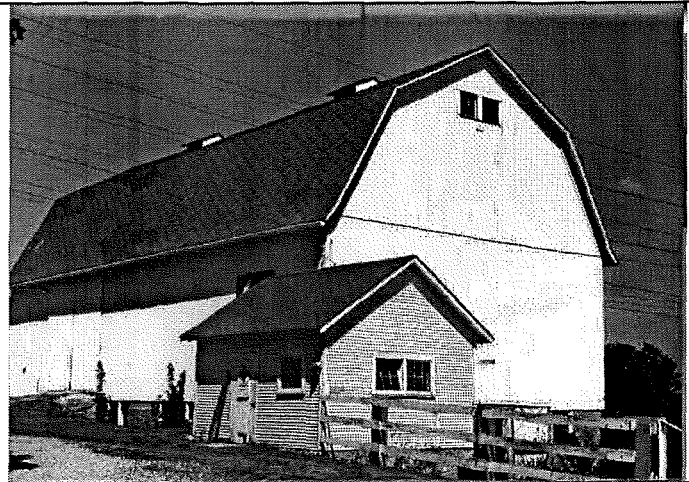
Roll No./Neg. No.: HH/34

Circa: 1910-1930	Condition: Good	Integrity: Good
----------------------------	---------------------------	---------------------------

Materials:	HISTORY:
Foundation: Stone and concrete	Ramped
Walls: Vertical plank	Double vented
Roof: Asphalt shingle	Attached milkhouse (gable, stone foundation)
Porch:

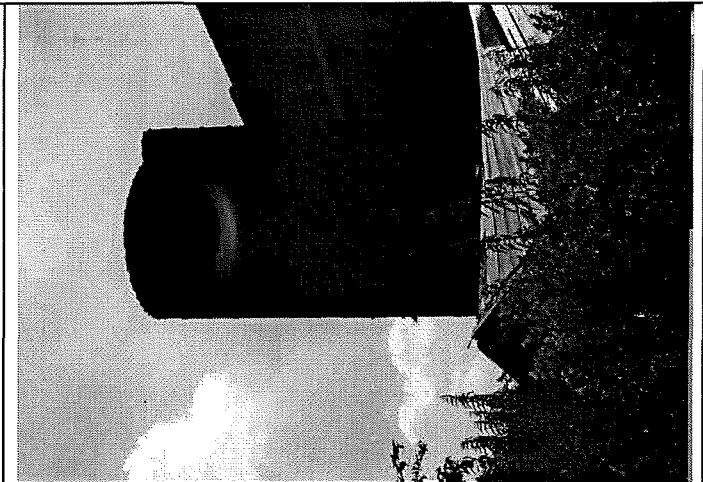
Circa: 1920	Condition: Poor	Integrity: Poor
-----------------------	---------------------------	---------------------------

Materials:	HISTORY:
Foundation: Concrete Walls: Concrete staved Roof: Missing Porch:	No remarkable feature

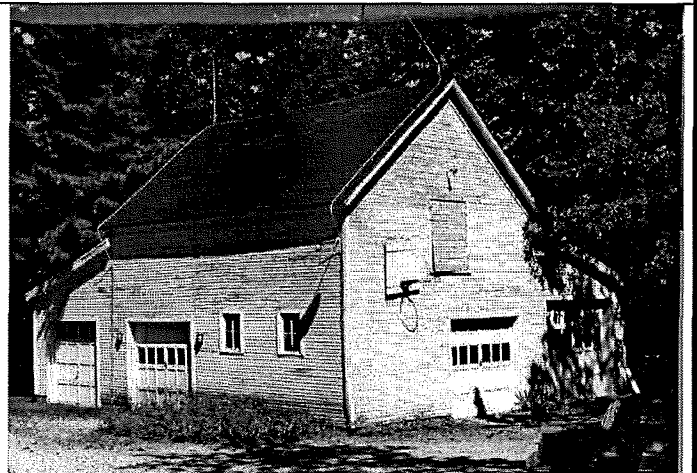
Circa: 1940	Condition: Good	Integrity: Fair
-----------------------	---------------------------	---------------------------

Materials:	HISTORY:
Foundation: Concrete	Small barn now used for storage
Walls: Clapboard	4 up and over doors (added)
Roof: Asphalt shingle	Converted to garage and machine storage
Porch:

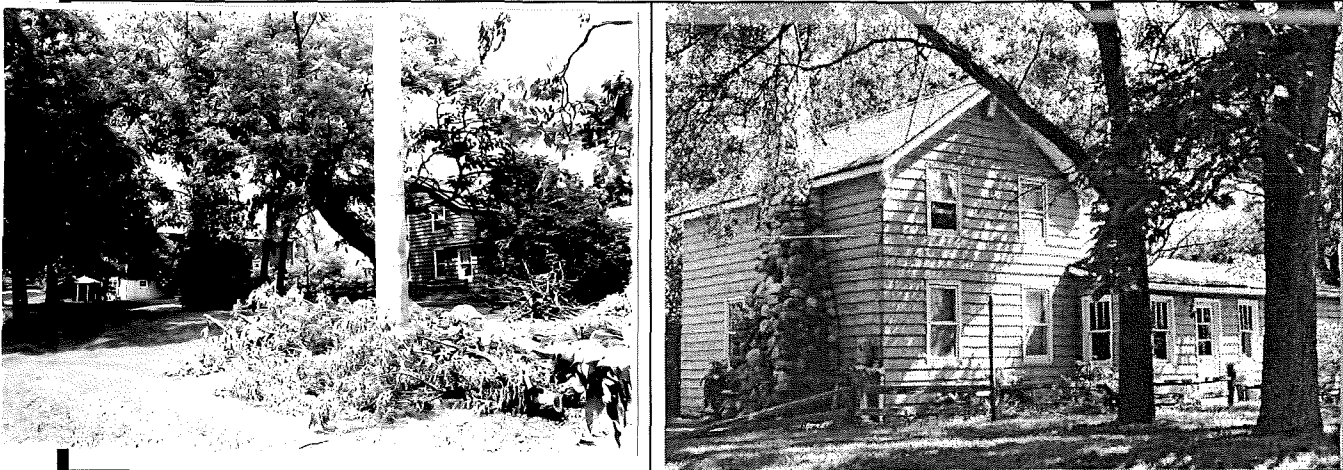
Roll No./Neg. No.: HH/26 **Surveyed by:** KD & LM **Date:** 7-28-98

Function:	Vernacular Type:	Arch. Style:	Alterations:
Residence	Upright and wing		Addition to rear Replacement windows

Circa: 1860 - 1930	Condition: Good	Integrity: Poor
------------------------------	---------------------------	---------------------------

Materials:	HISTORY:
Foundation: Stone and concrete	Residence and barn noted on previous survey
Walls: Aluminum siding	Prominent stone chimney on side of house (added later)
Roof: Asphalt shingle	Italianate corbels in the eave of front gable
Porch: Enclosed porch at front	
	Previous survey = 1976

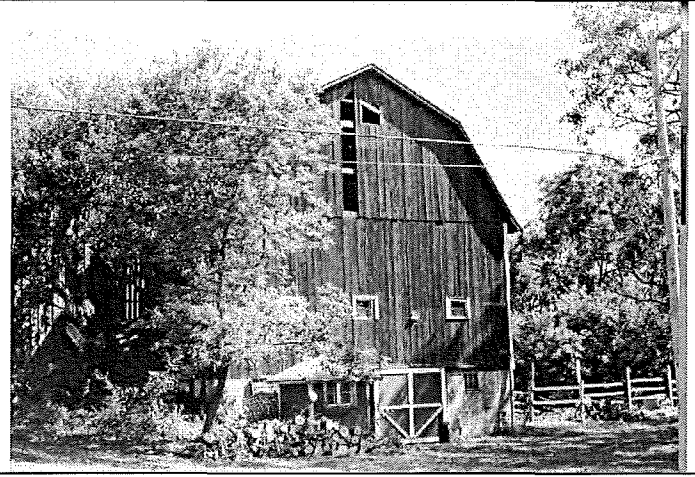
Circa: 1910 - 1930	Condition: Fair	Integrity: Good
------------------------------	---------------------------	---------------------------

Materials:	HISTORY:		
Foundation: Concrete	Transverse aisle		
Walls: Vertical plank	Small windows line the lower level		
Roof: Asphalt shingle	Ramped		
Porch:	Remains of a concrete staved silo

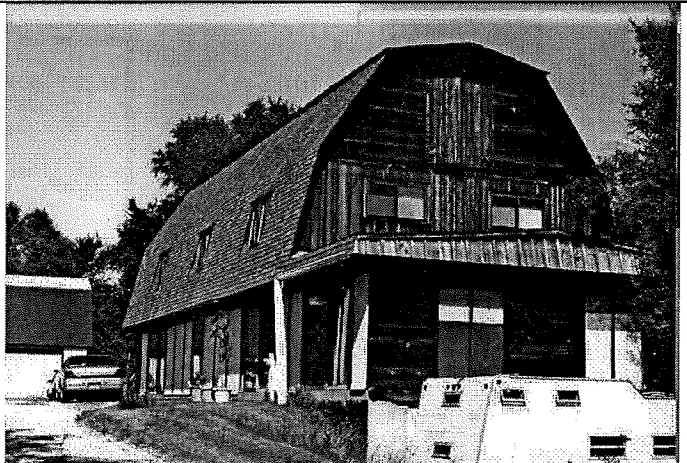
Circa: 1900	Condition: Fair	Integrity: Poor
-----------------------	---------------------------	---------------------------

Materials:	HISTORY:
Foundation: Concrete	
Walls: Board and batten in some areas	
Roof: Asphalt shingle	
Porch: Added at front	
	Not on previous survey
	Has a basement
	Has been converted to a 2 story & attic residence

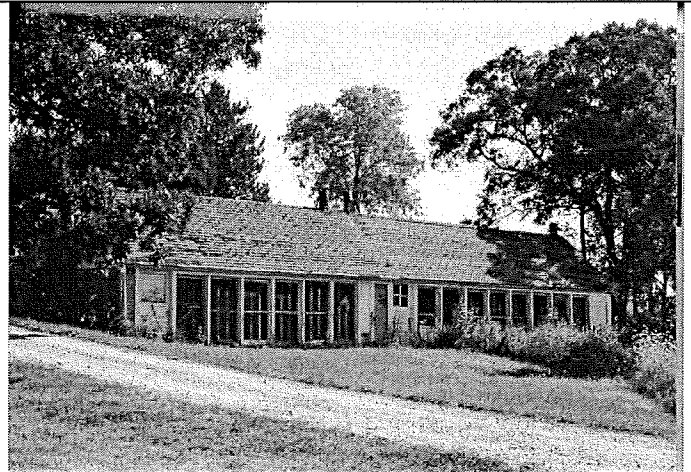
Circa: 1910 - 1930	Condition: Poor	Integrity: Good
------------------------------	---------------------------	---------------------------

Materials:	HISTORY:
Foundation: Stone	
Walls: Stone and clapboard	
Roof: Asphalt shingle	
Porch:

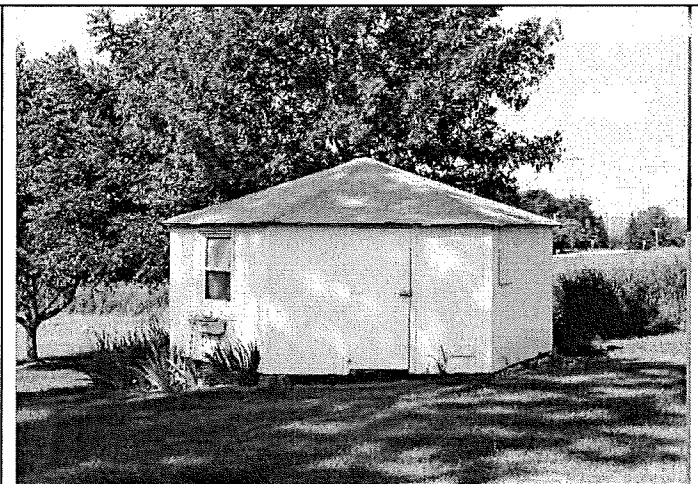
Circa: 1910	Condition: Poor	Integrity: Good
-----------------------	---------------------------	---------------------------

Materials:	HISTORY:
Foundation: Raised on concrete blocks	A window or door on all sides but one
Walls: Vertical plank	Conical roof
Roof: Asphalt shingle	
Porch:

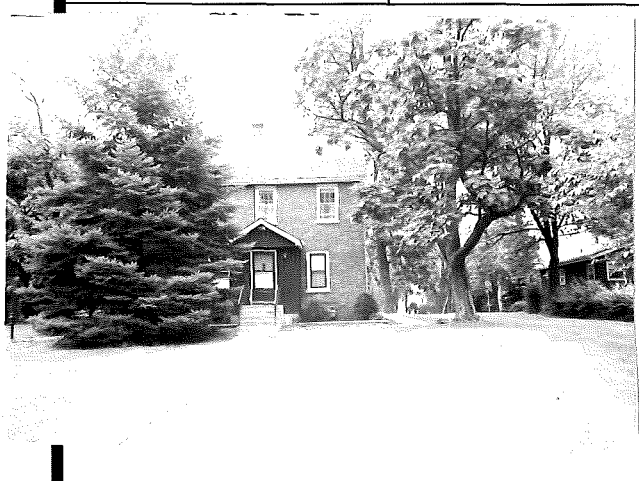
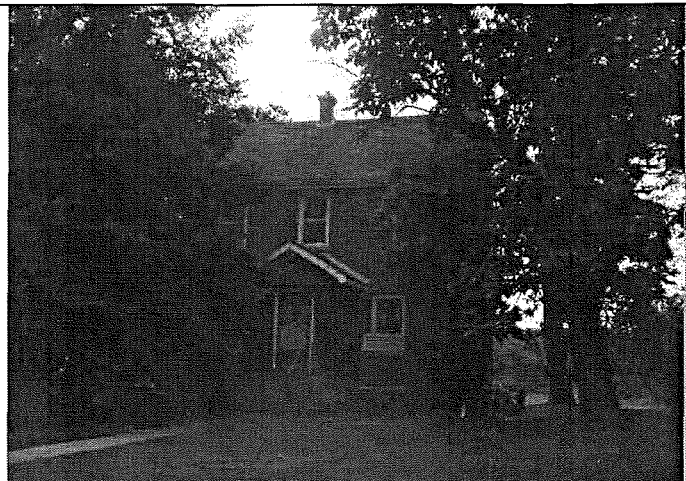
Roll No./Neg.No.: NN17

Circa: 1860-1880	Condition: Good	Integrity: Poor
-------------------------	---------------------------	---------------------------

Materials: Foundation: Stone Walls: Brick Roof: Asphalt shingle Porch:	HISTORY: Previous survey notes that the house originally was wooden, not brick 2 story single central chimney Previous site = 1981&1982
--	---

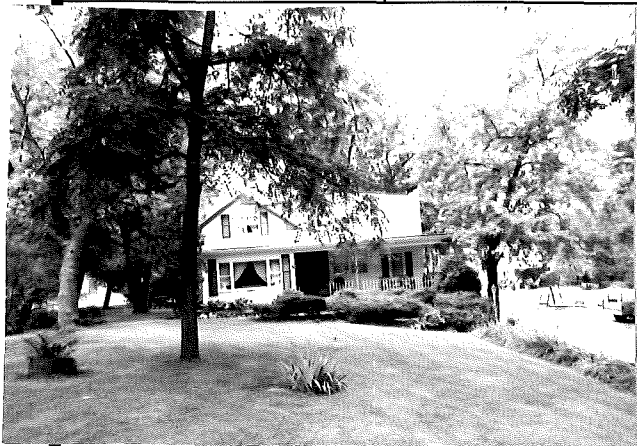
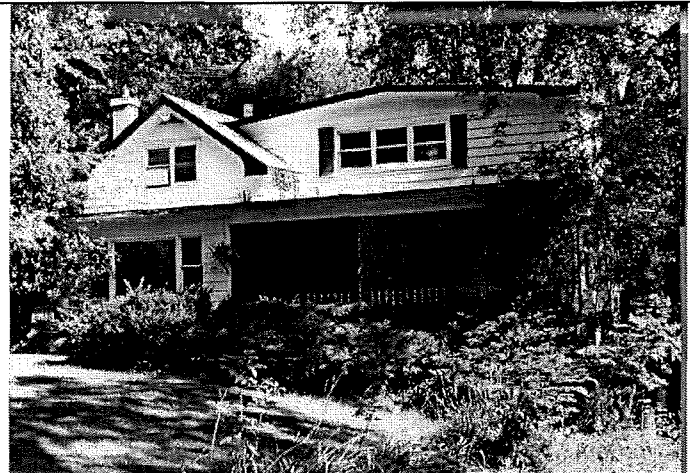
Roll No./Neg. No.: HH/19

Function:	Vernacular Type:	Arch. Style:	Alterations:
Residence	Upright and wing		2 nd floor added on wing Replacement windows

Circa: 1860 - 1880	Condition: Good	Integrity: Poor
------------------------------	---------------------------	---------------------------

Materials:	HISTORY:
Foundation: Stone and concrete Walls: Aluminum siding Roof: Asphalt shingle Porch: Front and rear screened in	Unique detailing in eaves added later Has a basement walk-out (built into the side of a hill) The 2 nd story side gable has a very flat slope Previous site = 1977 & 1978

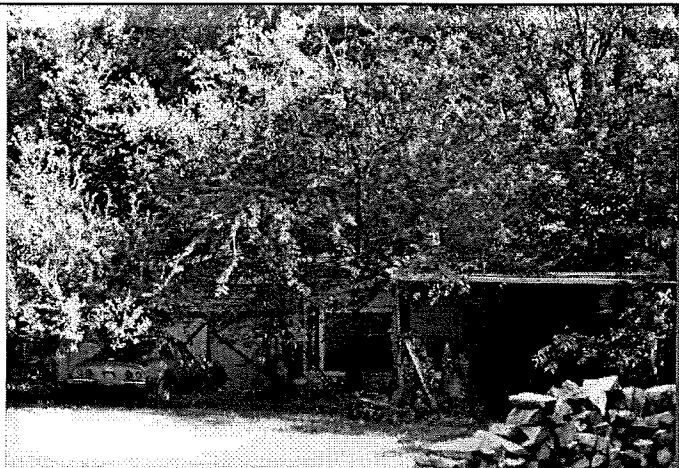
Roll No./Neg. No.: HH/21 **Surveyed by:** KD & LM **Date:** 7-28-98

Circa: 1920	Condition: Poor	Integrity: Poor
-----------------------	---------------------------	---------------------------

Materials:	HISTORY: 2 front dormers About to collapse and heavily obscured by growth
Foundation: Concrete	
Walls: Clapboard	
Roof: Asphalt shingle	
Porch:

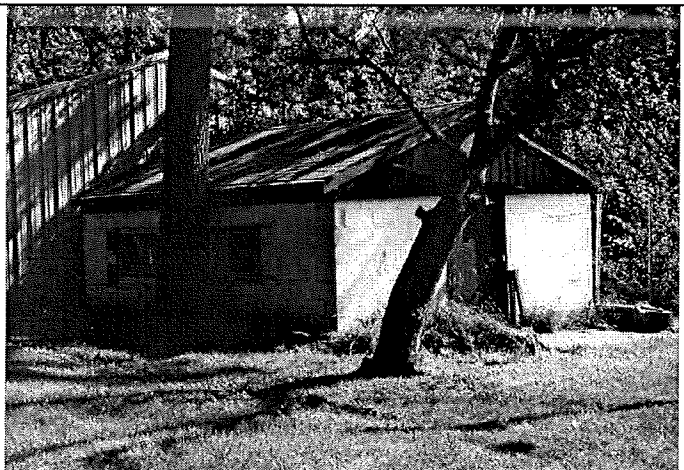
Roll No./Neg. No.: HH/20

Circa: 1930 - 1945	Condition: Poor	Integrity: Poor
------------------------------	---------------------------	---------------------------

Materials:	HISTORY: No windows, one door
Foundation: Concrete	
Walls: Concrete block	
Roof: Asphalt shingle	
Porch:

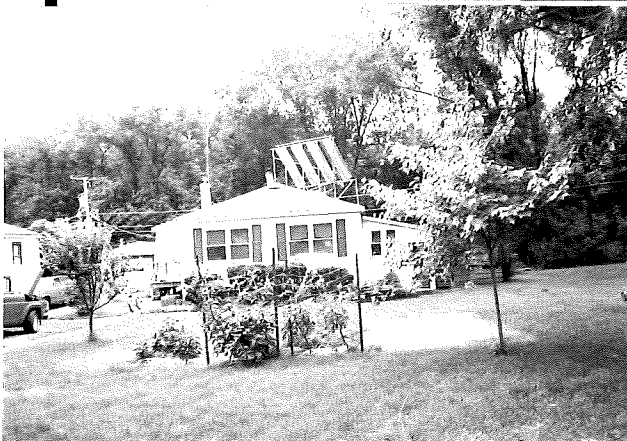
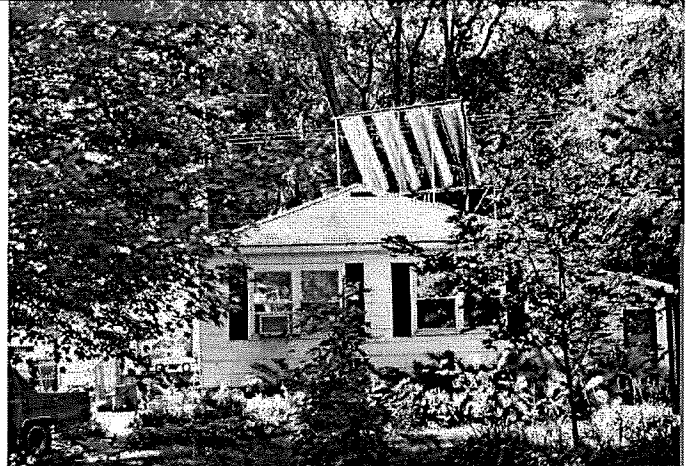
Roll No./Neg. No.: HH/23 **Surveyed by:** KD & LM **Date:** 7-28-98

Circa: 1910-1930	Condition: Fair	Integrity: Poor
----------------------------	---------------------------	---------------------------

Materials:	HISTORY:
Foundation: Stone	1 car garage next door with rear additions
Walls: Asbestos	Hipped roof
Roof: Asphalt shingles	
Porch:	Previous site = 1983
